Camden Residents' Action Group Incorporated Camden – Still a Country Town

4 March 2020

Re: BP Service Station 12 Argyle St Camden Development Approval (DAs: 257/2018; 411/2017) **Consent Conditions** 13 December 2018

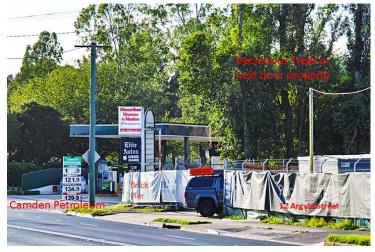
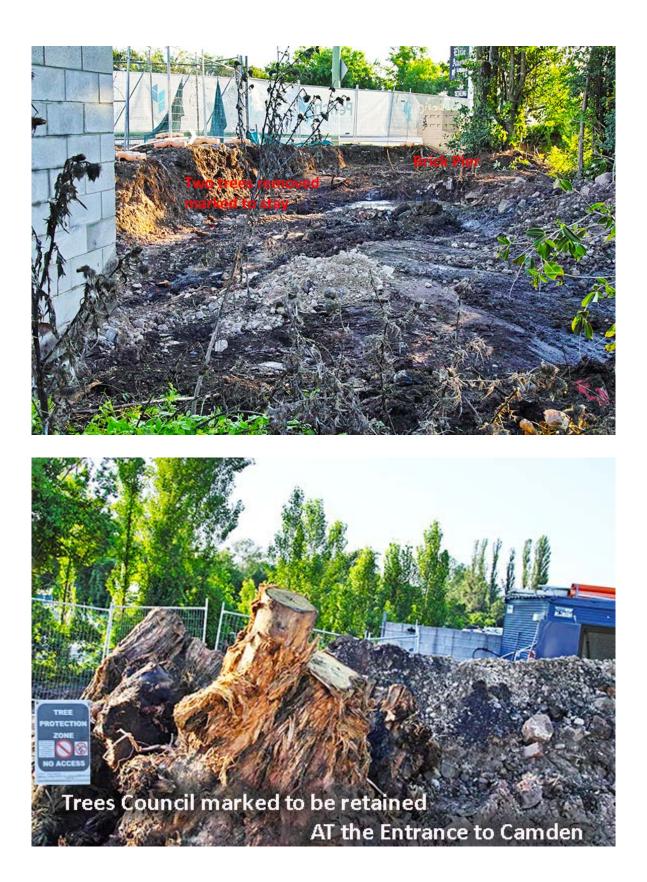
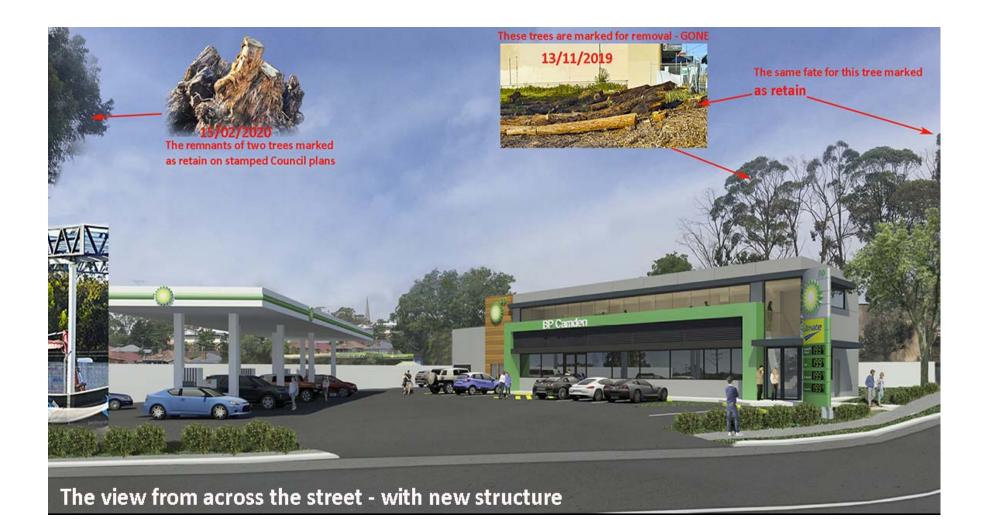
The trees 'to be retained' are gone, as shown in the following photos.

Why weren't the trees marked 'to be retained' retained? It is impossible to accept that the trees marked for retention had to be removed due to some uncontrollable environmental problem which targeted specific trees on the site.

There appears to be a violation of the consent conditions.

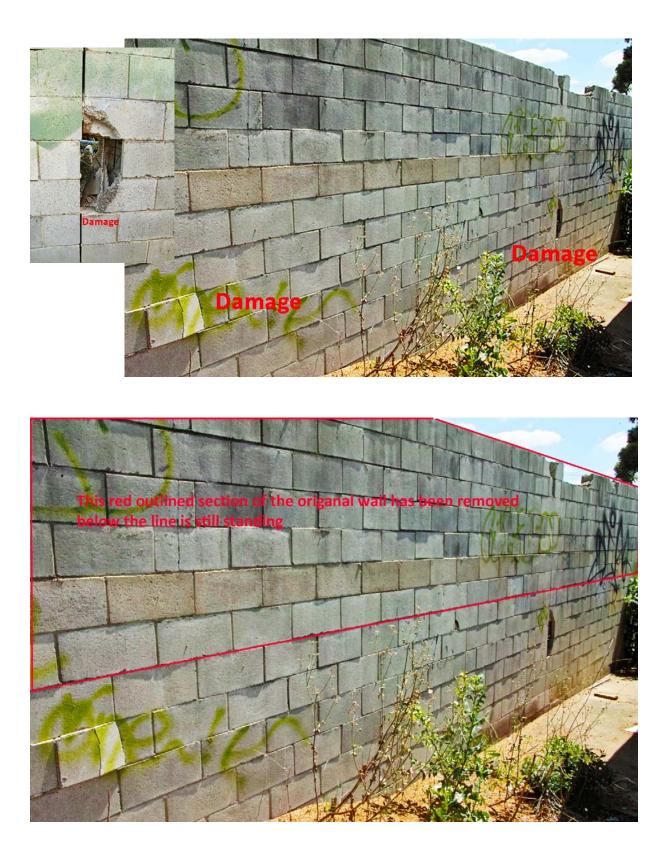
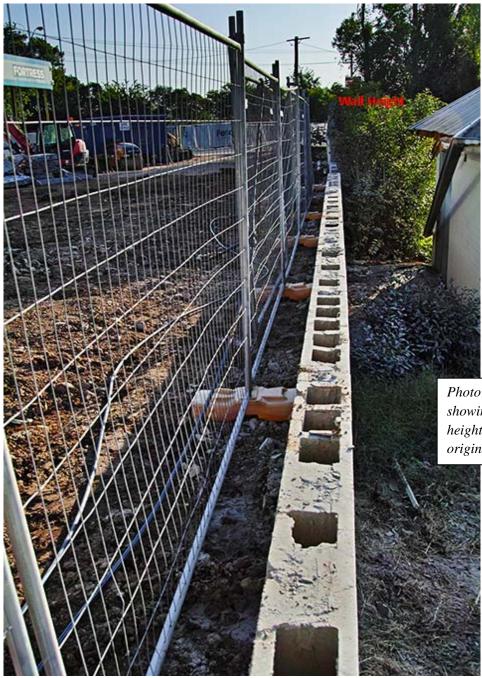
Further, although this wall, built in sections with steel rods at least 60 years ago, was to be retained⁹ subject to engineering certification as to its soundness, it has been damaged, is more than half demolished and at the time of writing its old foundation near the entrance to the site is in the process of being broken up.

Photo 3 March 2020 showing original wall height and removal of original block work

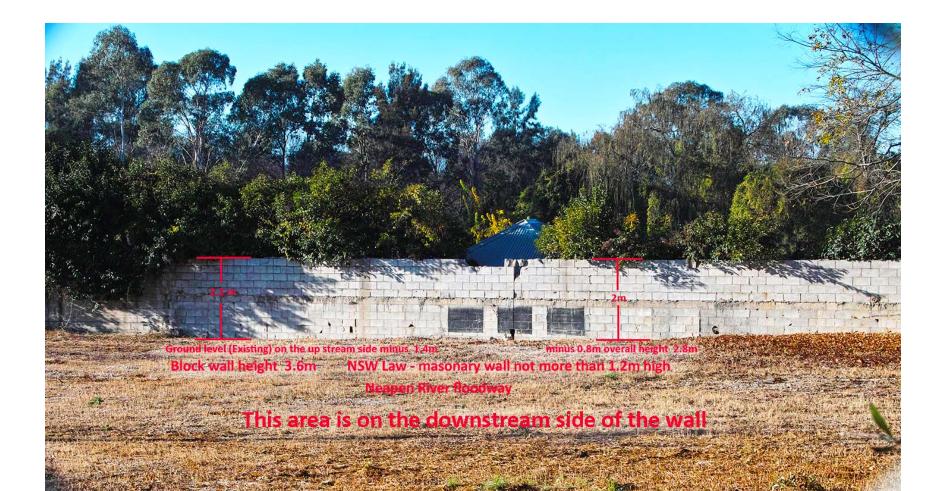
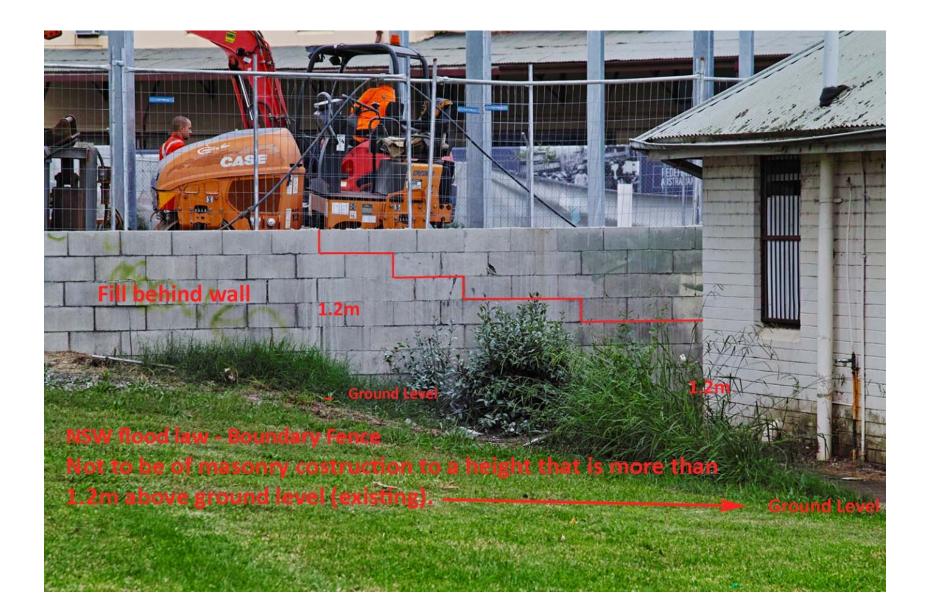
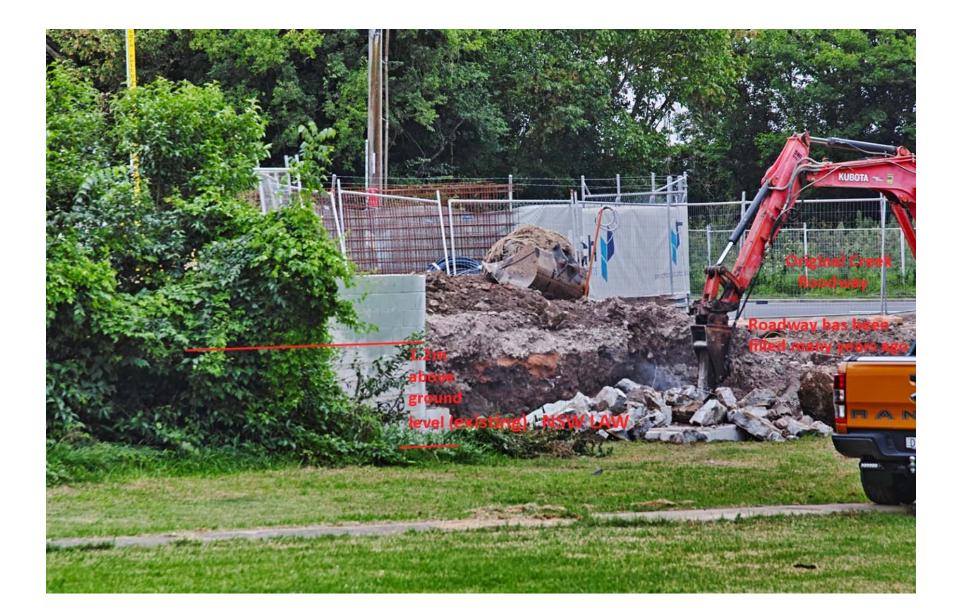
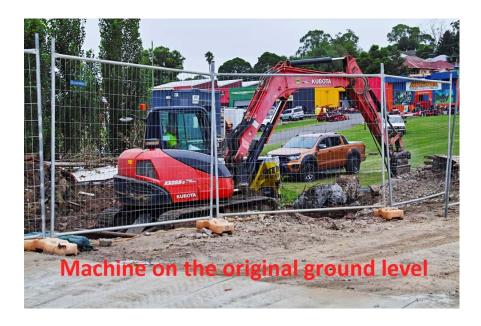
At this point damage is evident in the remaining original block wall. At this point it is not clear whether the wall is to be reconstructed. It is clear that the extensive work on the wall at the construction stage would need the input of engineering expertise and certification.

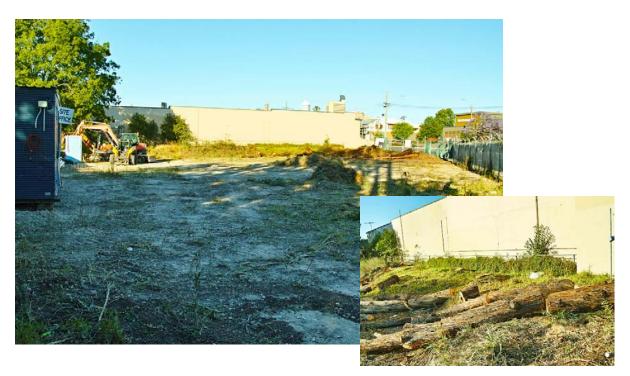
Photos 13 November 2019: Work has commenced.

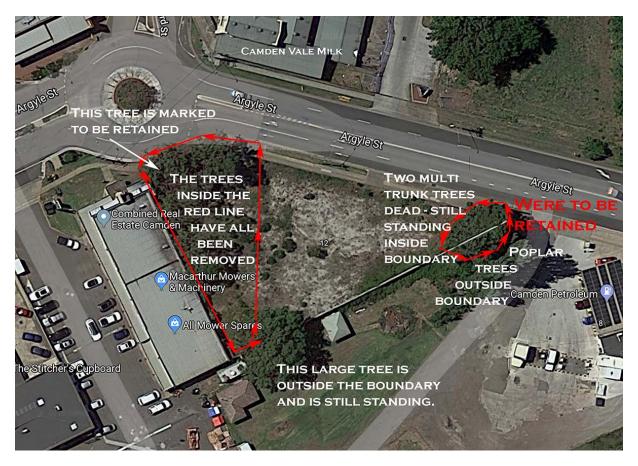
As depicted below it appears that the requirement and expectation that the development would retain trees within the site to soften its modern starkness at the main entrance to the historic town has not eventuated.

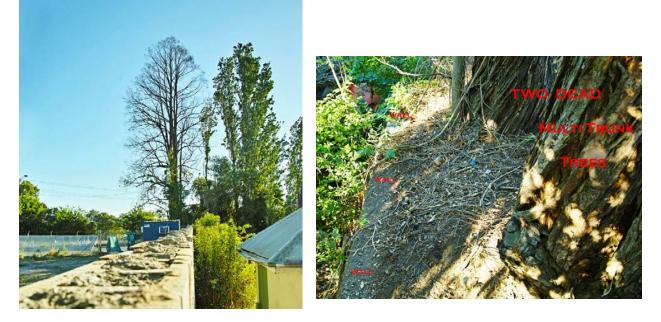
Photos: 15 November 2019

Why are these trees defoliated?

If the trees need fertilisation and watering then this can be remedied. If the trees have been subject to inappropriate treatment then an arboreal expert may be able to recover their health.

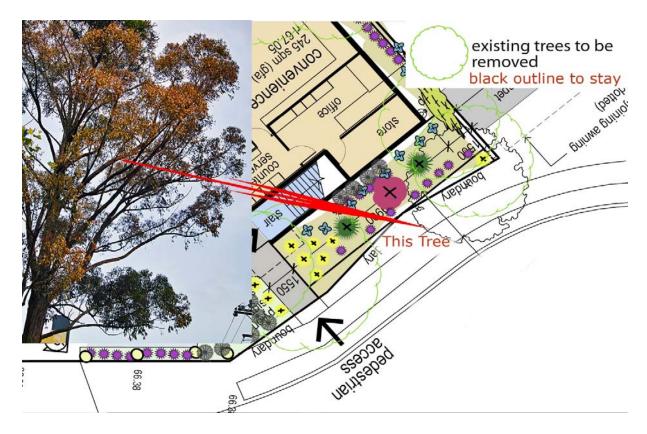
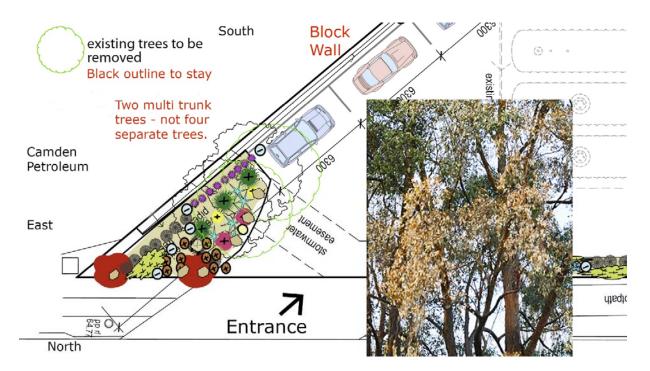
We understand that at least some of the trees that are observed to be in poor health and dying are within the boundary of the site of the above-mentioned service station development.

We would like to request as a matter of urgency that Council investigate why trees appear to be dying within and/or near to the site of the above-mentioned development, and act to save them.

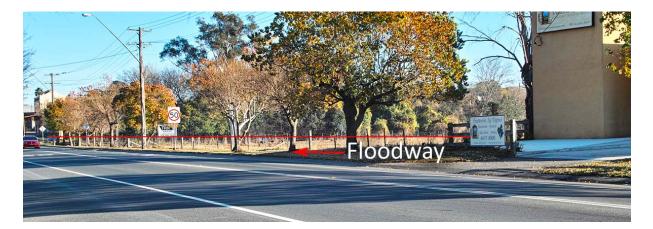
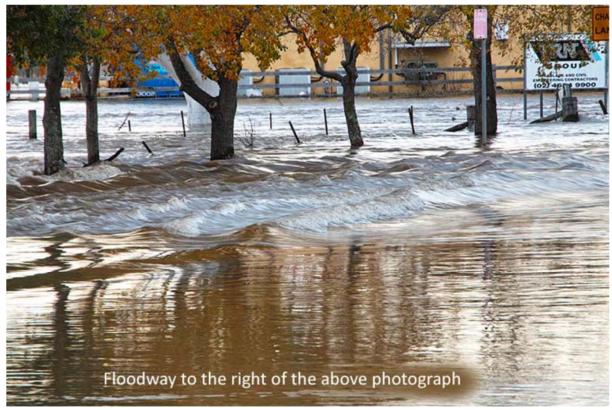
June 2016

Local knowledge is that the wall, in the event of a flood, is in the path of fast-moving flood waters and in danger of collapsing and potentially causing injury and damage. The wall needs to be reinforced.
