Camden Residents' Action Group

11 May 2020

Re: BP Service Station
12 Argyle St Camden
Development Approval (DAs: 257/2018; 411/2017)
Consent Conditions
13 December 2018

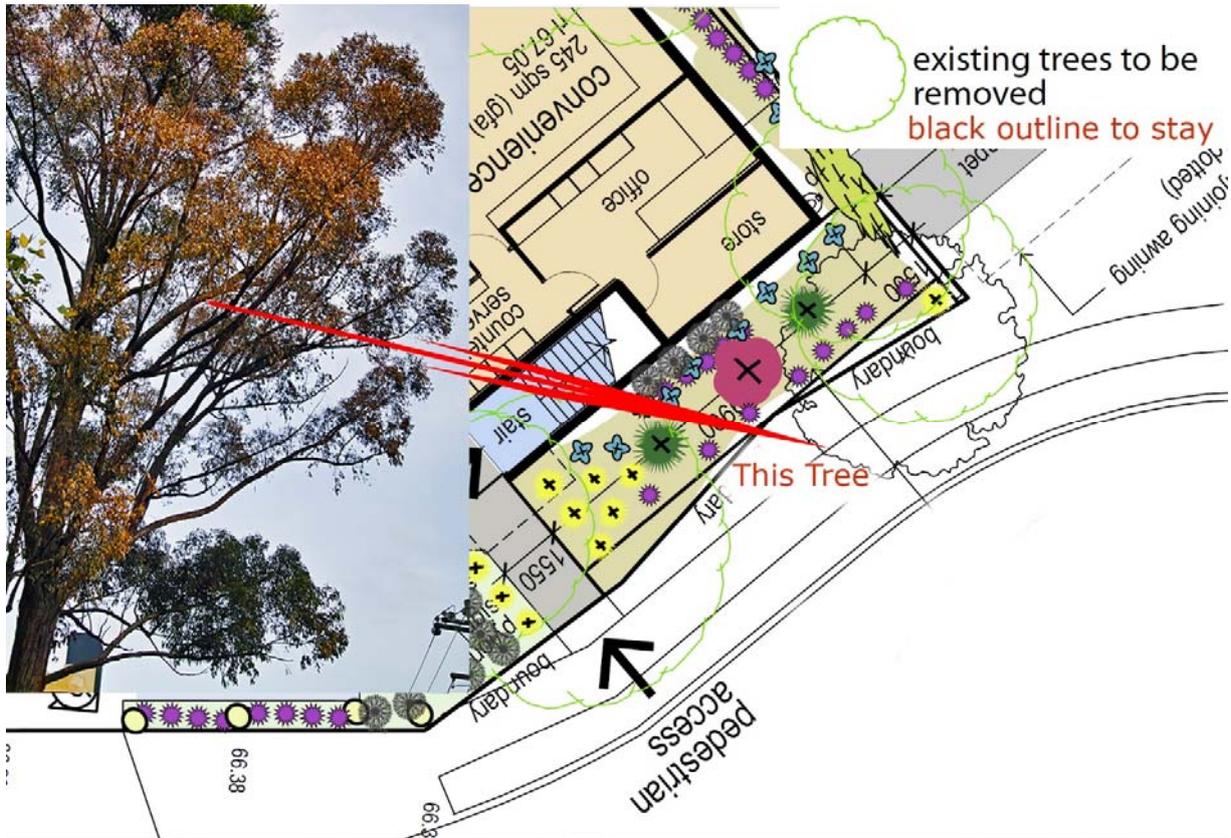
West View

No explanation was provided in this Tree Report as to why the trees that were healthy were now dead or dying and no explanation as to why the trees were not saved.

However, it was clear that the health of the trees to be retained was deteriorating long before the recent drainage works, as shown below by the inset photos taken in mid-June 2019. As noted above we documented and first formally raised the issue with Council on 14 August 2019, three months prior to the date of the Tree Report and long before the drainage works.

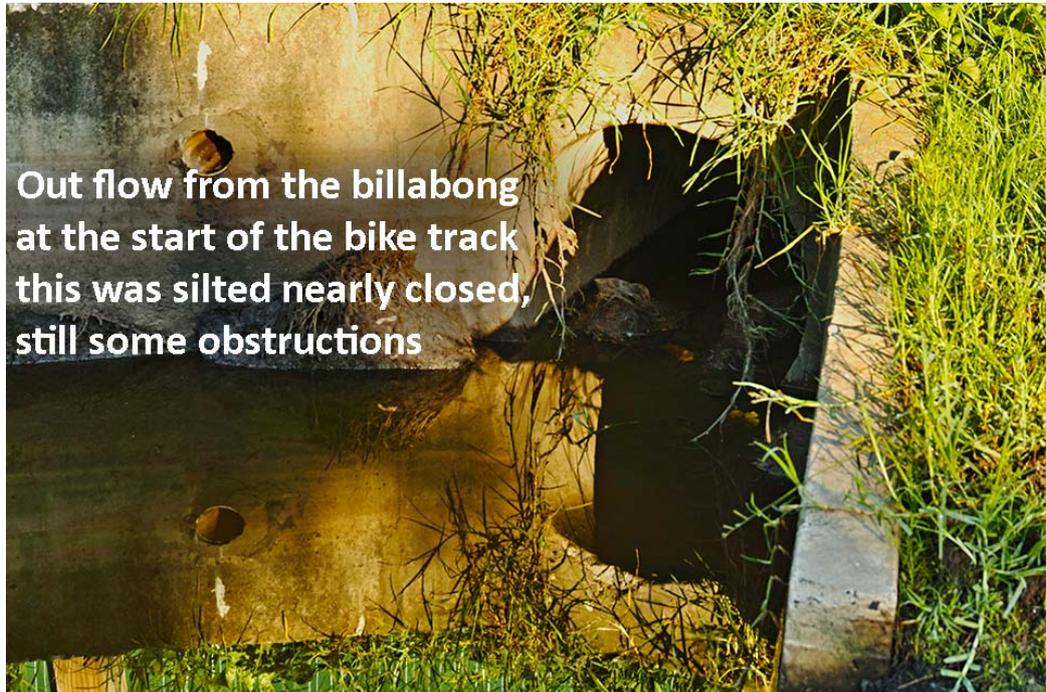
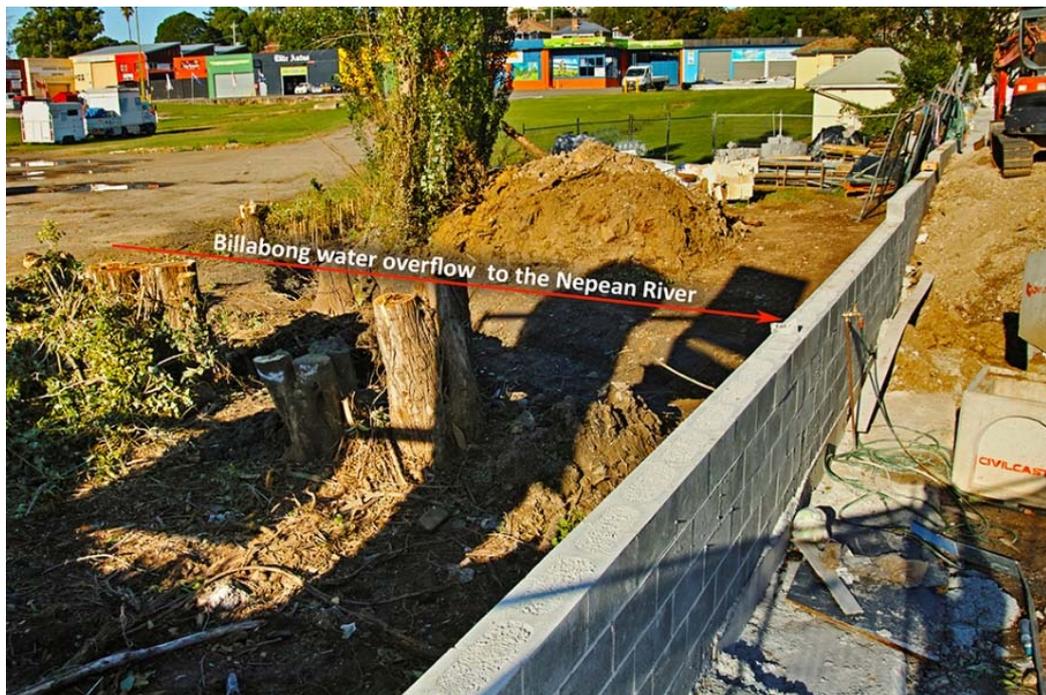
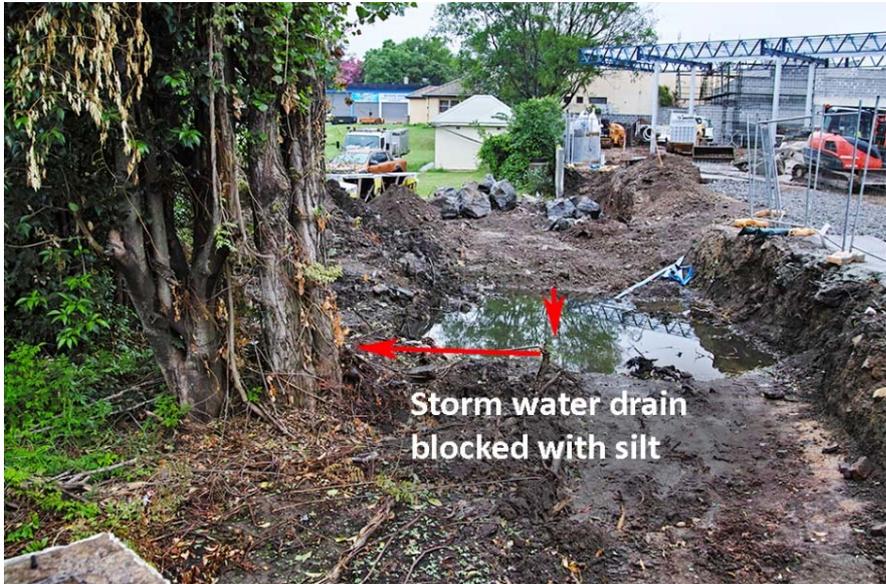
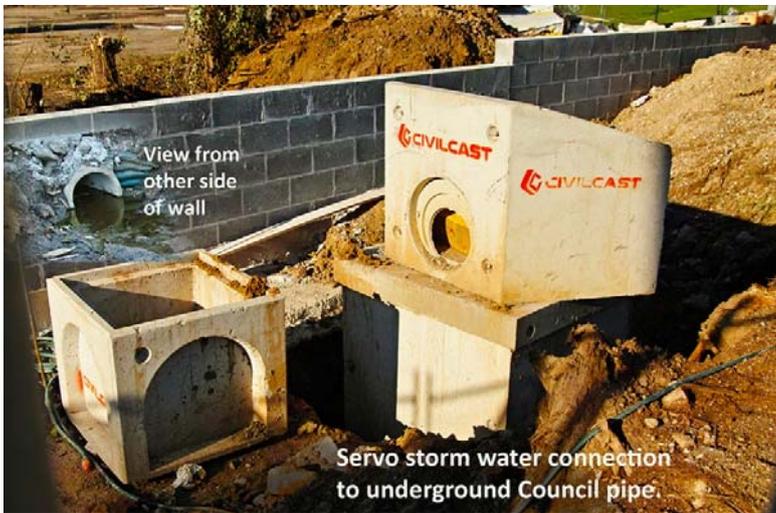
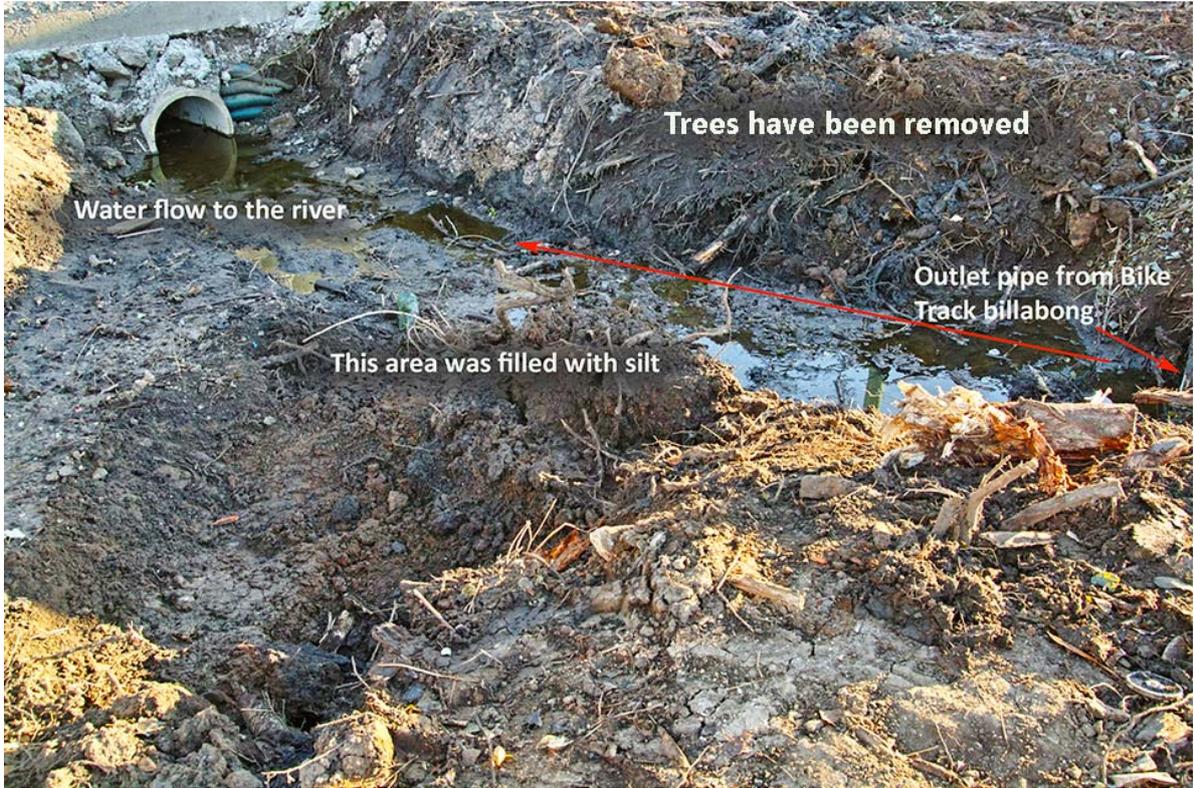
APPENDIX: Recent 2020 activity affecting development site

Extensive drainage work has recently been observed by the community as shown in photos provided to us on 7 May 2020 (see Appendix). This has led to speculation that in order to position a digger to clear drain blockages that trees needed to be removed and that another tree fell over in strong winds due to encroachment into its Structural Root Zone (SRZ) or Tree Protection Zone (TPZ) by the drainage works.

Water flow to the river

Trees have been removed

Outlet pipe from Bike
Track billabong

This area was filled with silt

The community expects that the loss of the trees should be and will be remediated appropriately. We note that the Tree Report dated 17 November 2019 recommends 100 litre replacements in close proximity to the trees that were to be retained.
