Camden Residents' Action Group

URGENT REQUEST FOR MEETING **Argyle St works and health of Jacaranda and other street trees**

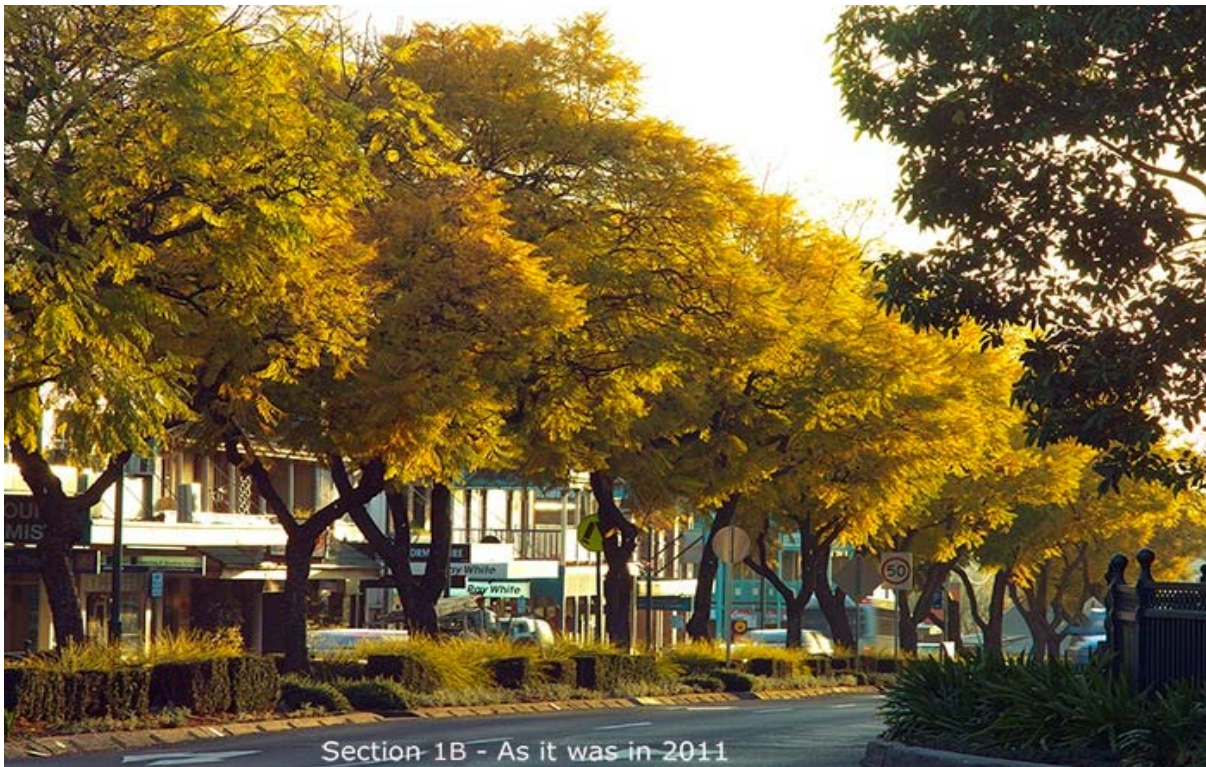
The photo above shows the healthy trees and median strip of Section 1B in 2011.

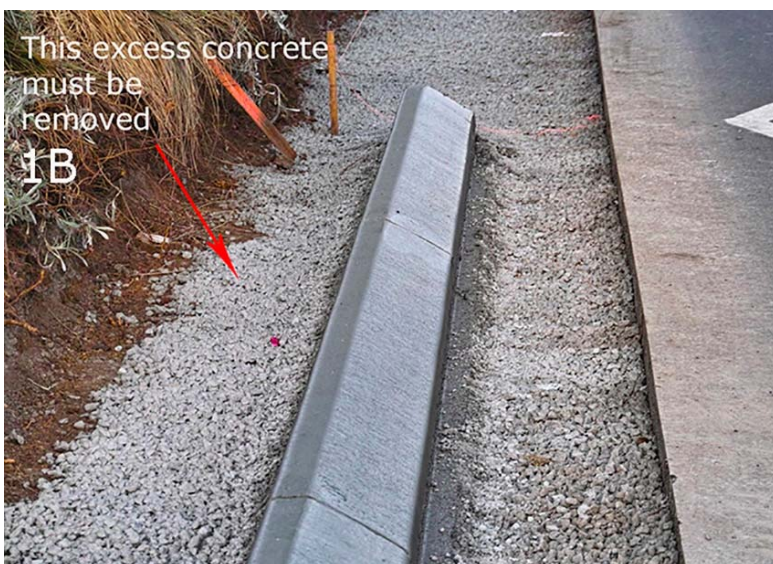
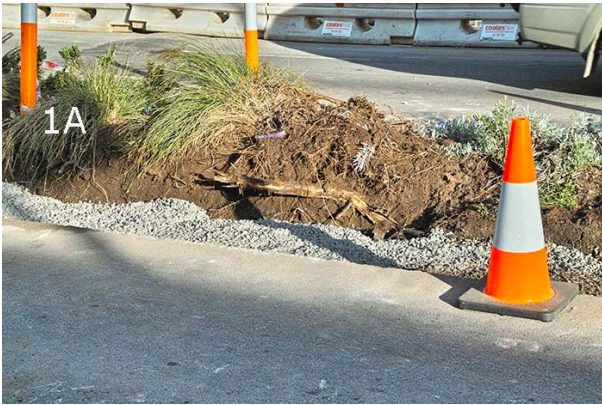
The following photos show the Section 1B median strip works in 2016.

On the Westpac side of Argyle Street, the trench and concrete are too close to the trees.

There is a wide trench and concrete inside the kerb line used to facilitate a level path for the machine laying the kerb. The wide concrete is to make a level platform for the kerb making machine to travel on which is convenient for the contractors, but detrimental to the health of the trees. The contractors should be required to

use a concrete saw to remove the excess width of concrete.

The contractors should also have been required to remove the excess concrete of the Stage 1A works.

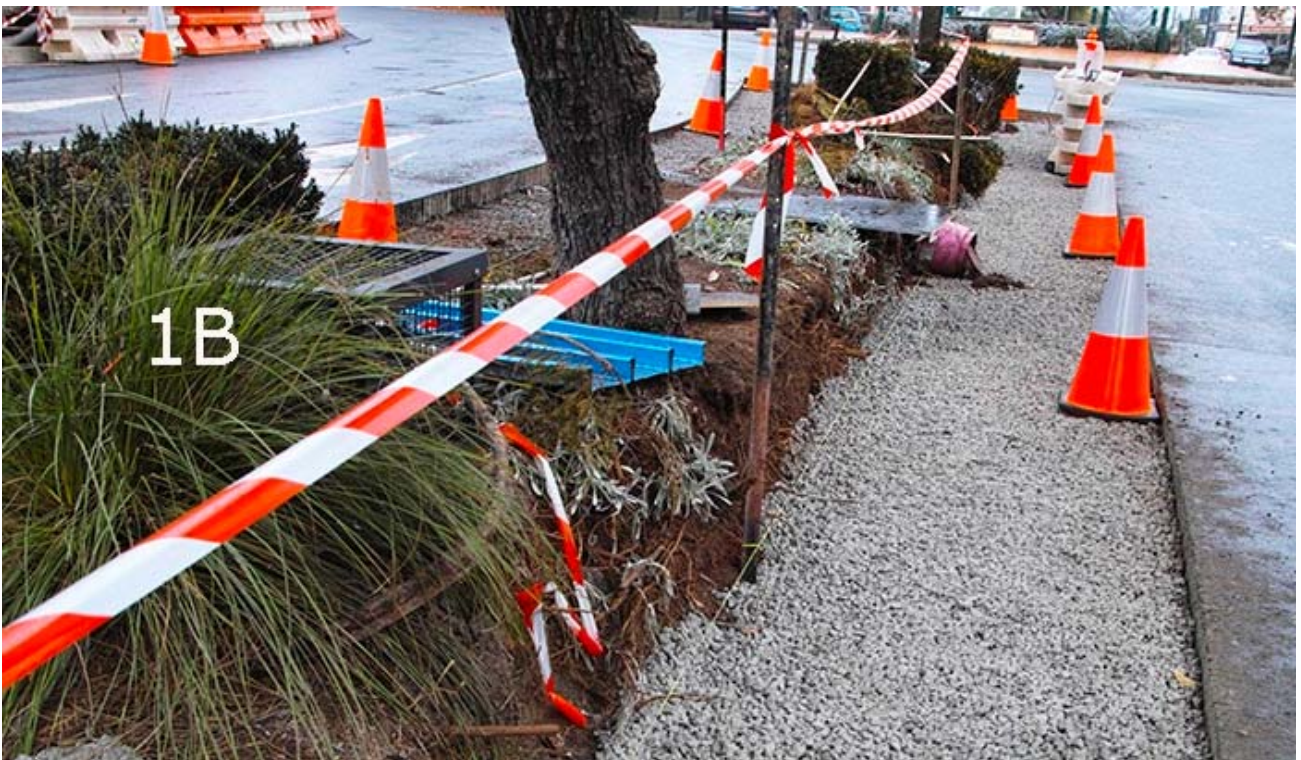
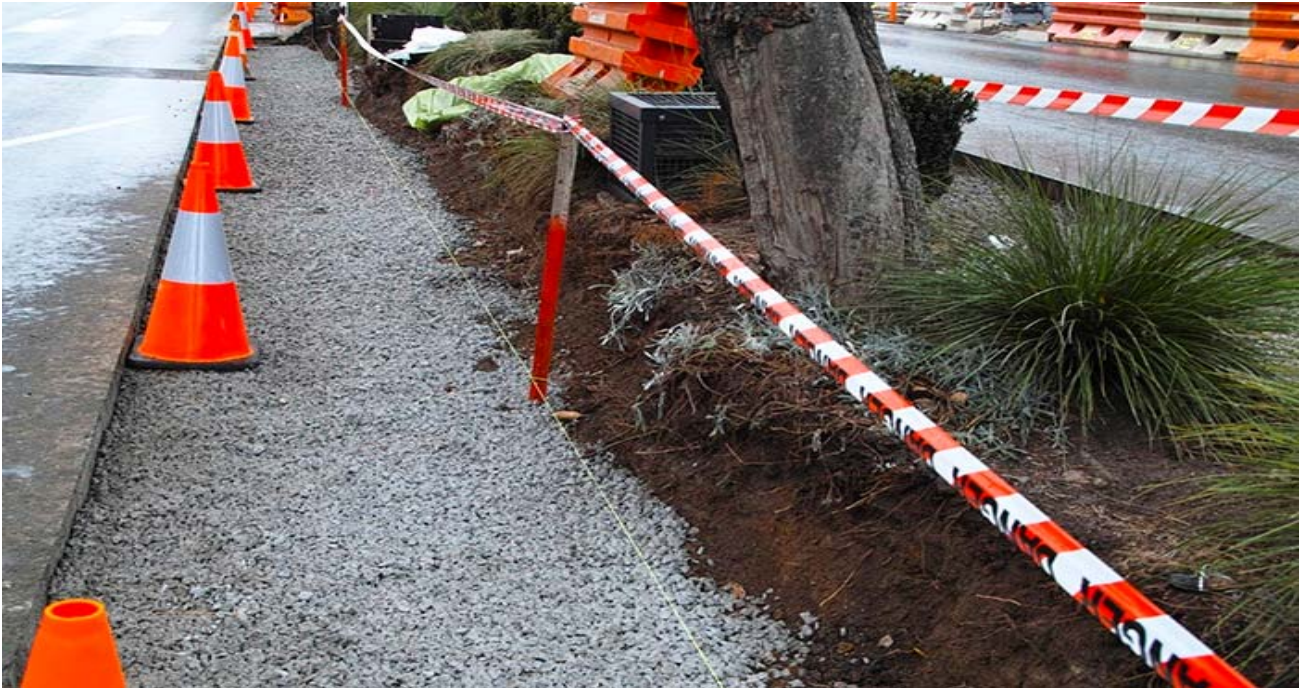
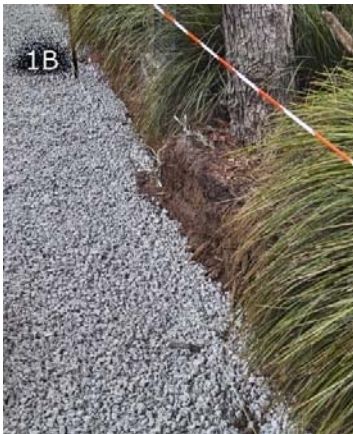
As can be clearly seen in the photos below, the width of the median strip has been reduced, with the new wide strip of concrete around the Argyle Street median strip garden now significantly closer to the jacaranda trunks and covering a larger area of the root systems. One side is closer than the other as the trees were not planted in the centre of the street and the lane widths are not the same.

If there is to be encroachment into the PRZ as is apparent, the Structural Root Zone (SRZ), an area considered essential for tree stability, must not be disturbed. Australian Standard 4970-2009 indicates that a tree with a diameter of 30cms has an SRZ radius of 2 metres.

Encroachment into the SRZ is obviously demonstrated in the photos above and opposite. This raises serious questions about safety and the management of the Argyle St works.

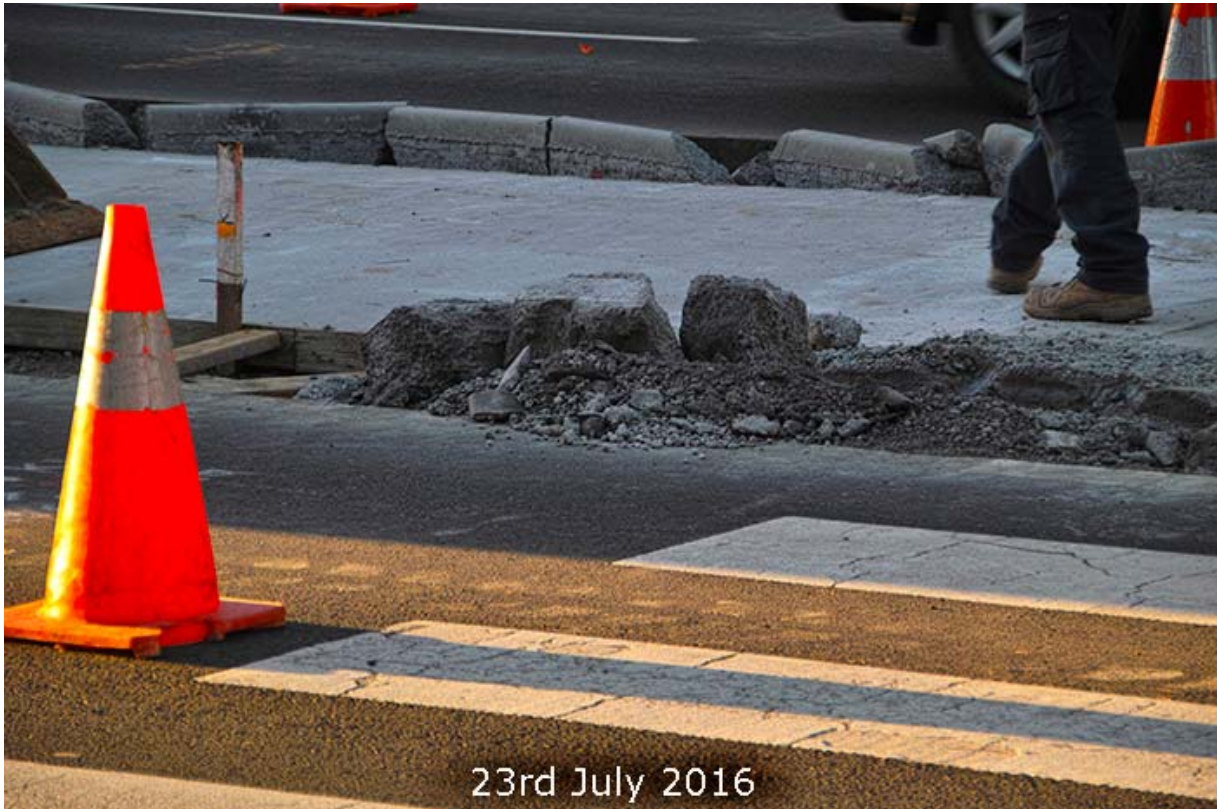
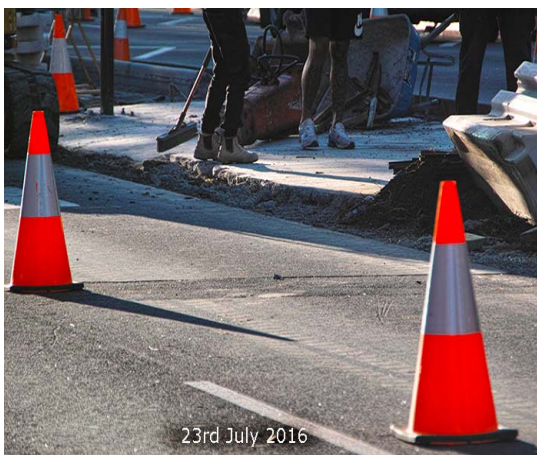
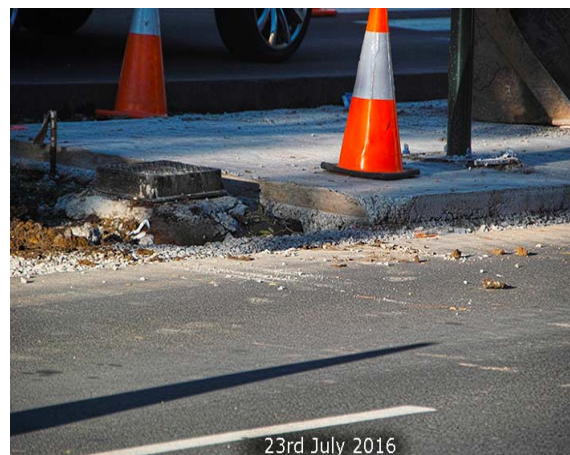
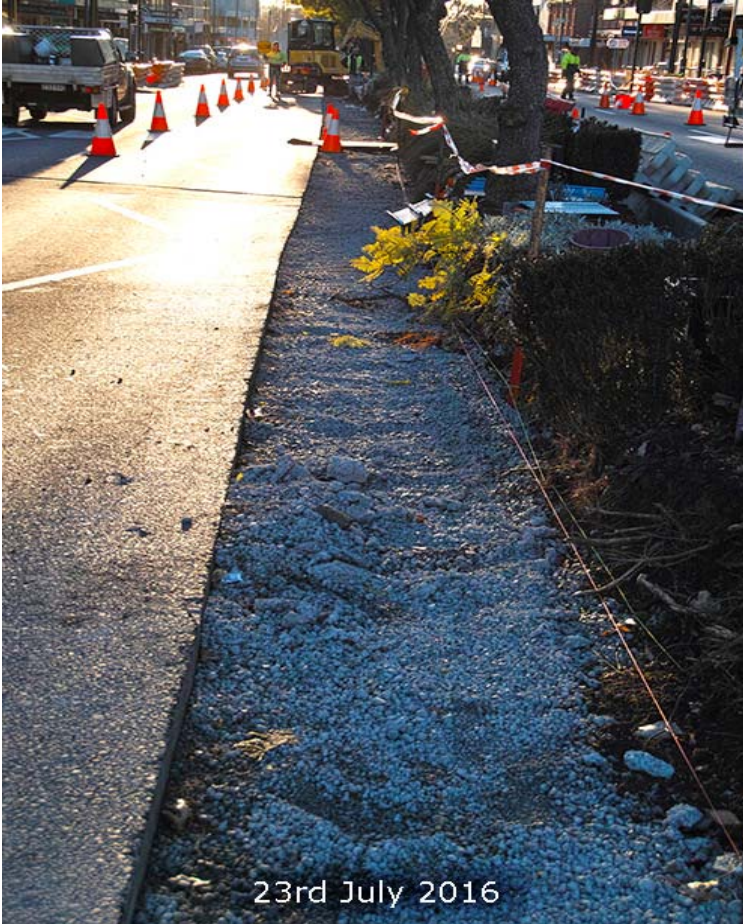
On 23 July 2016 the contractor removed the new kerb that was installed on the 18th July 2016 on the Westpac side of Argyle Street. There appears to have been a problem at the traffic lights section of the kerb installed on the 21st July. The lack of a precise planned engineering program is creating more disturbances, and no doubt cost, than necessary.

The jacaranda requires well-draining soil, and when subject to poor drainage can develop root rot. The assumption was that the concrete laid as an aid to construction so close to the root system, as amply demonstrated by the photos, would be removed.

However it was noted on 26 July 2016 that instead of the harmful concrete being removed, it is instead being covered over with soil and mulch, thereby hiding from the casual observer that the area beneath the trees is not soil containing accessible nutrients and moisture.

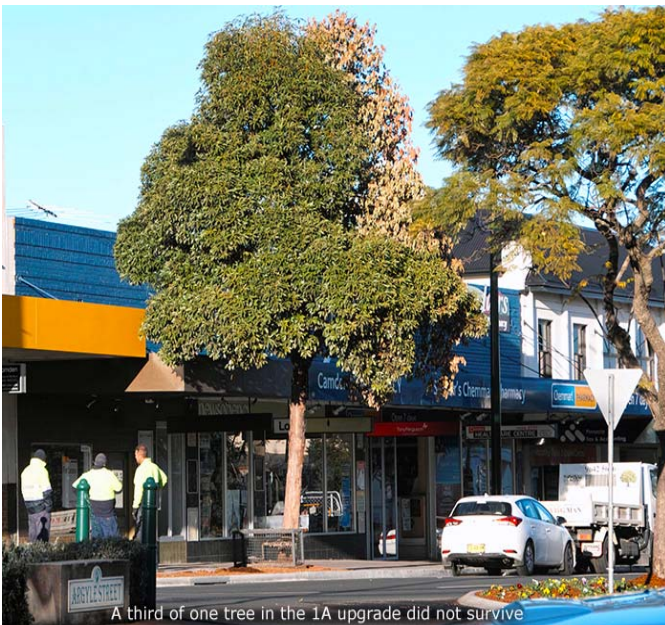
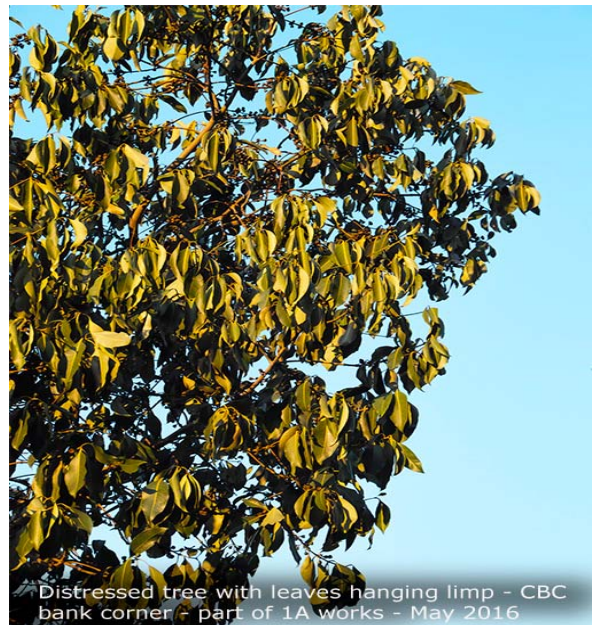
One only has to take note of how the native evergreen box trees (*Lophostemon confertus*) trees on the corners of John and Argyle Street, which are moderately drought tolerant⁴, were affected by the Stage 1A works in the short term through their primary root systems being chopped during the works and changing the area at their bases.

As is clearly demonstrated in the photos above, a third of one tree died and the leaves of another were limp and hanging straight down, not erect as they should be if all was well. Watering by Council truck was not nearly enough for them to survive. Only the heavy rain in June 2016 saved them.

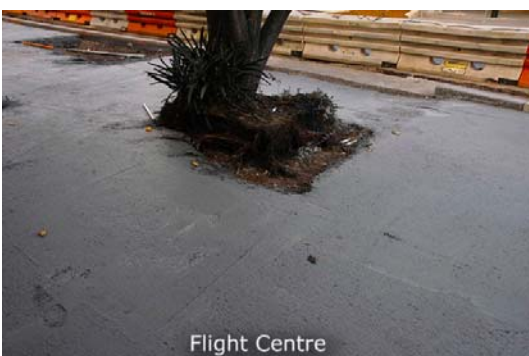
The reduction of open soil surrounds to capture water and interference with the root system of the tree at the Flight Centre corner of John and Argyle Streets during recent

Stage 1B works is yet to become evident.

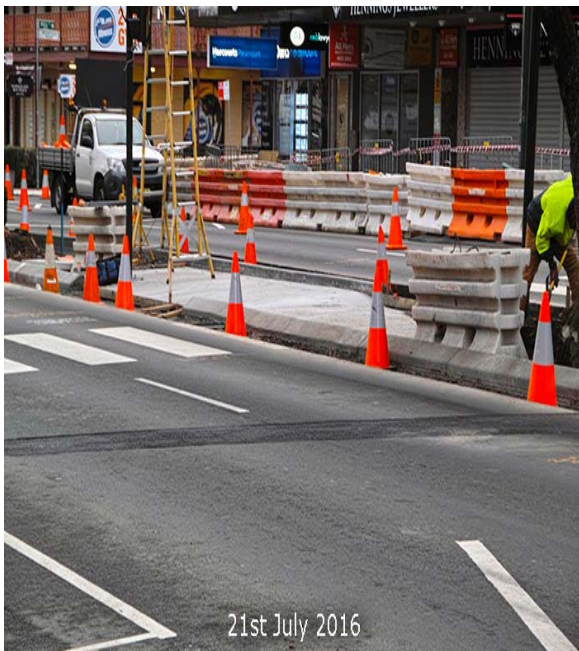
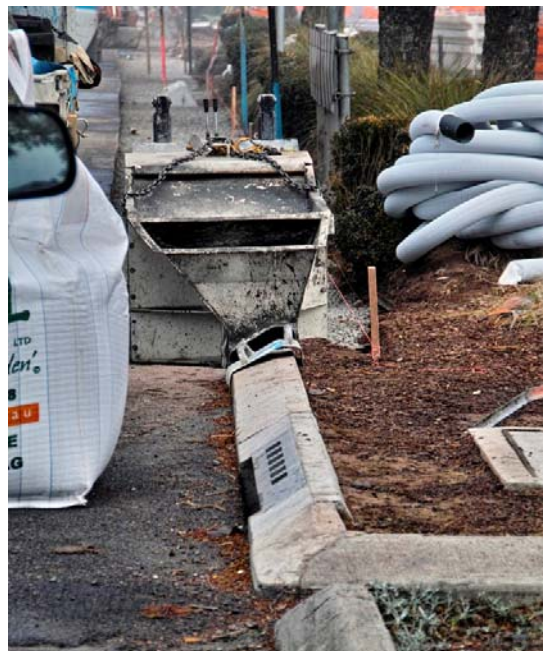
As shown in the photos below, the work site is currently very active with heavy machinery and without special care roots are likely to be compacted and mechanically wounded.
