St. John's Anglican Church Precinct Menangle Road, Camden

CONSERVATION MANAGEMENT PLAN

Prepared for:
The Anglican Parish of St. John, Camden

Date:
Final – March 2004

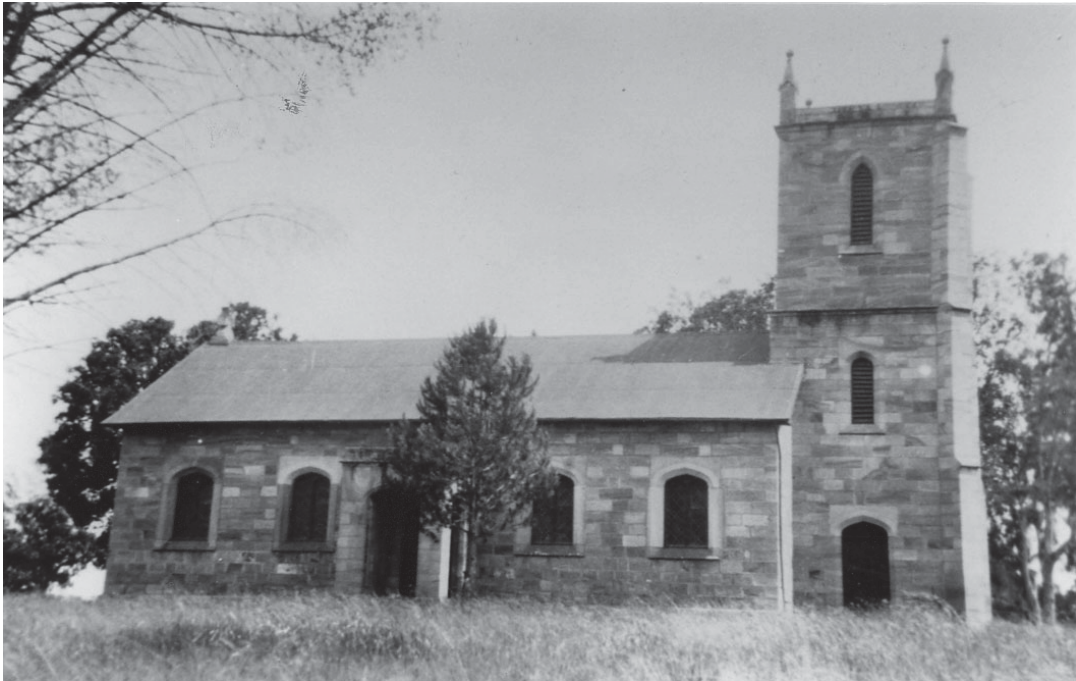
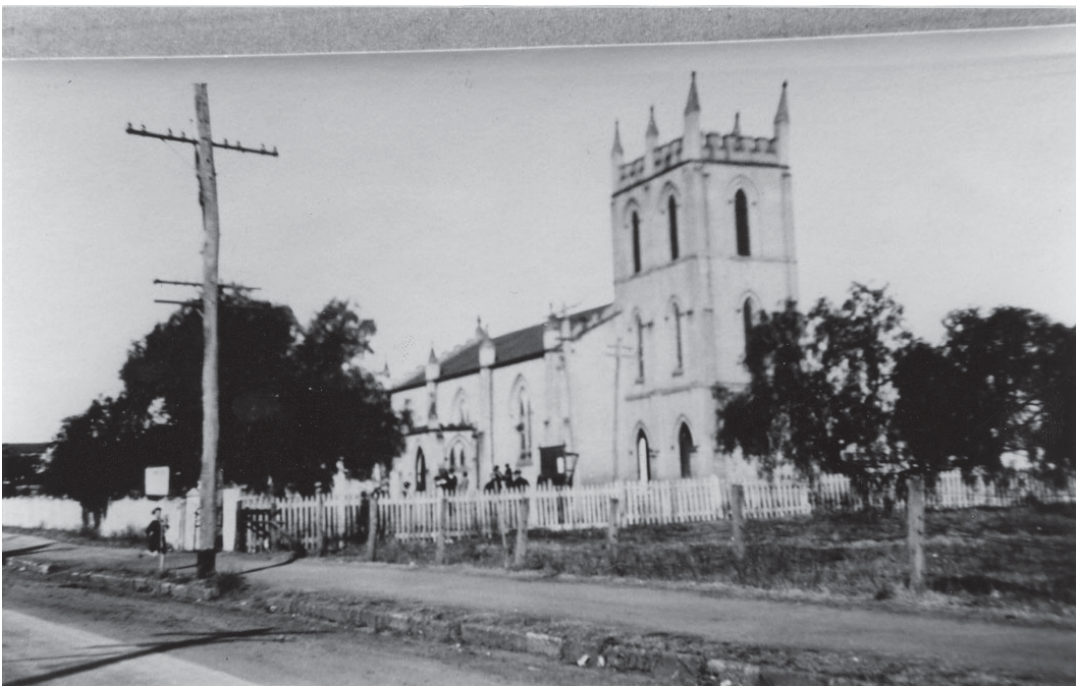
Figure 4.1: Comparative Analysis

Upper: St Thomas' Church, Mulgoa

Lower: St Stephen's Church, Penrith

- **St Thomas, Mulgoa.** Consecrated in **1838** to a design by James Chadley, architect. The church is in the Perpendicular Gothic Revival style. Built of stone. Tower added in 1840. Originally had gallery and box pews. The first example of a Gothic Revival style hammer beam roof built in New South Wales. The four-centred windows contain examples of Gothic Perpendicular tracery (see Figure 4.1).

- **St Thomas', Mulgoa**. The foundation stone was laid in 1836, and the church consecrated in September 1838. The church was closely associated with the Cox family; Edward Cox gave 10 acres for the church, and a further 40 acres was given by George Cox for the rectory (see Figure 4.1).

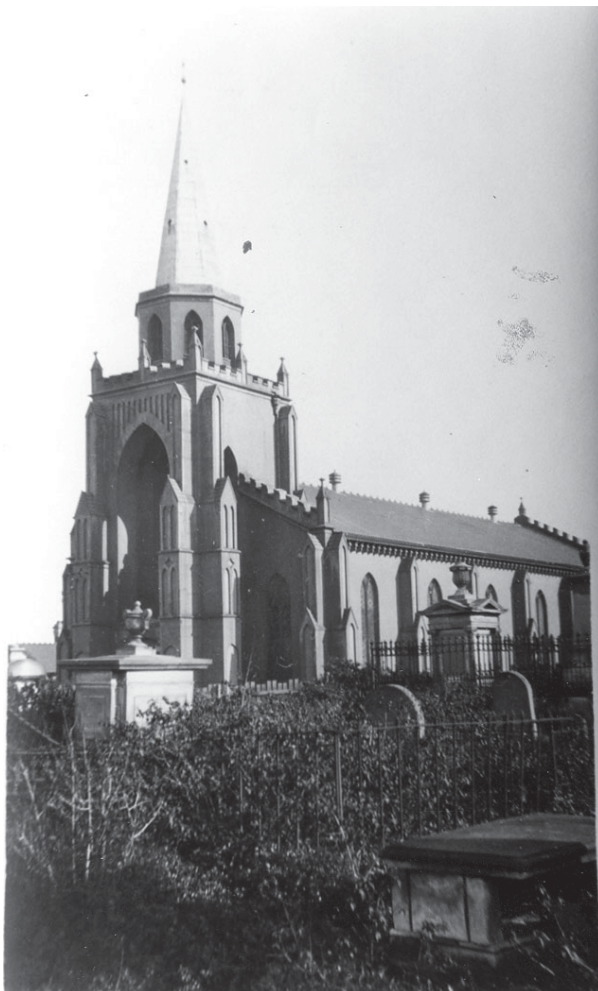
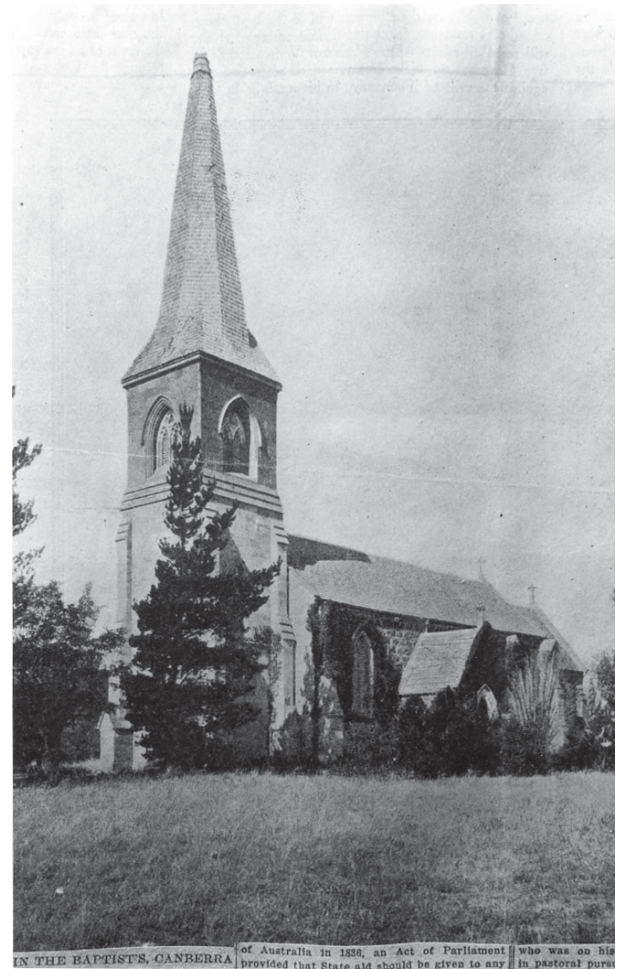
Figure 4.2: Comparative Analysis

Lower: St Peter's Church, Cooks River

- **St Peter's, East Maitland.** Constructed between **1838** and 1843. Architect: James Hume.
- **St Peter's, Cooks River, now Tempe.** Gothick church, the original portion being completed in **1839** to a design by Thomas Bird. Contemporaries described the church as 'the most beautiful specimen of Gothic Architecture in the colony'. Rebuilt in stages from 1846 (see Figure 4.2).

St John the Baptist, Reid, ACT. Foundation stone laid in **1841** and consecrated in 1845. Gothic style church of three bays in local bluestone. The nave is the earliest section. Early alterations include new tower to replace the original tower the 1860s; chancel and crypt added in 1872; and spire added in 1878 (see Figure 4.2).

- **St John the Baptist**, now within the Canberra suburb of Reid, but originally built in 1842 to serve the local population of Duntroon and neighbouring settlers. The church was built by Robert Campbell of Duntroon, who contributed half the cost of £2000 of its construction. The family maintained a close relationship with the church. The nave for example was extended in 1872 with funds provided by George Campbell. In 1850 it was created an independent parish and a permanent rector was appointed (see Figure 4.2).

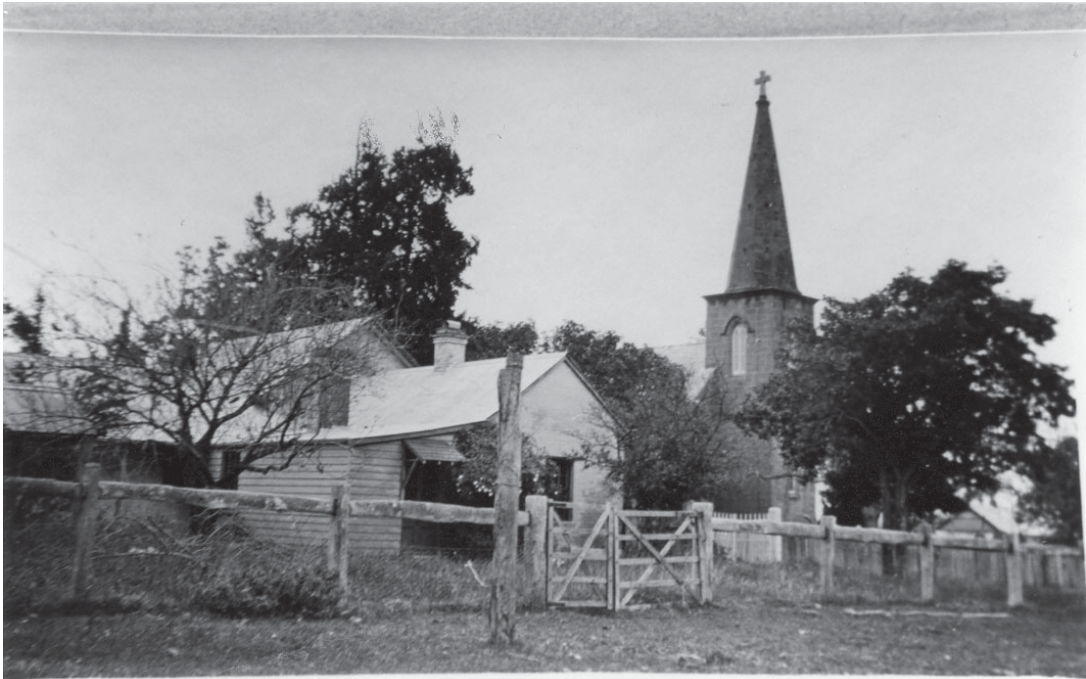
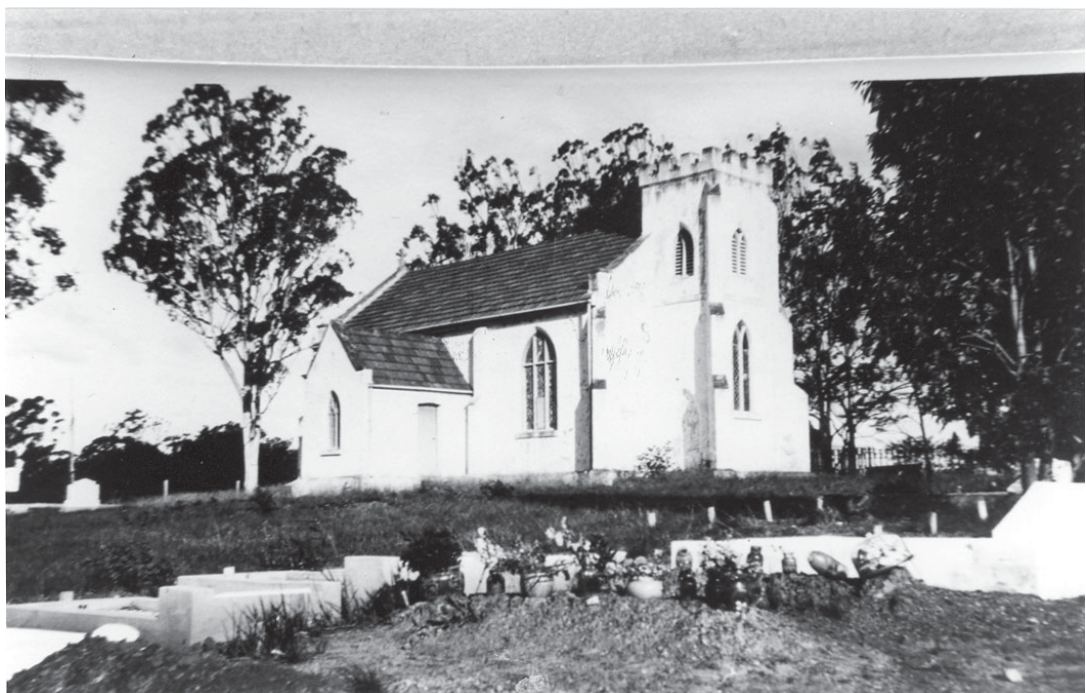
Figure 4.3: Comparative Analysis

Upper: St Paul's Church, Cobbity

- **St Mary's Chapel, Denham Court.** A private church completed in **1839** in the Regency Gothick style to a design by John Verge. The church is part of the Denham Court estate and built as a memorial to Captain Richard Brooks by Thomas Bloomfield and Patrick Hill (see Figure 4.3).

- **St Paul's Cobbitty.** Consecrated by Bishop Broughton in **1842** (see Figure 4.3). Designed by John Verge and John Bibb.

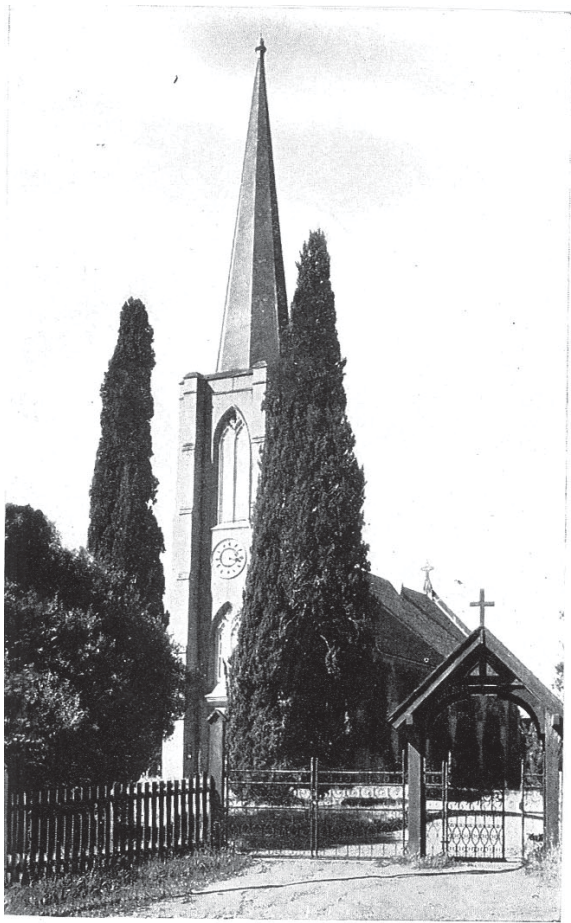
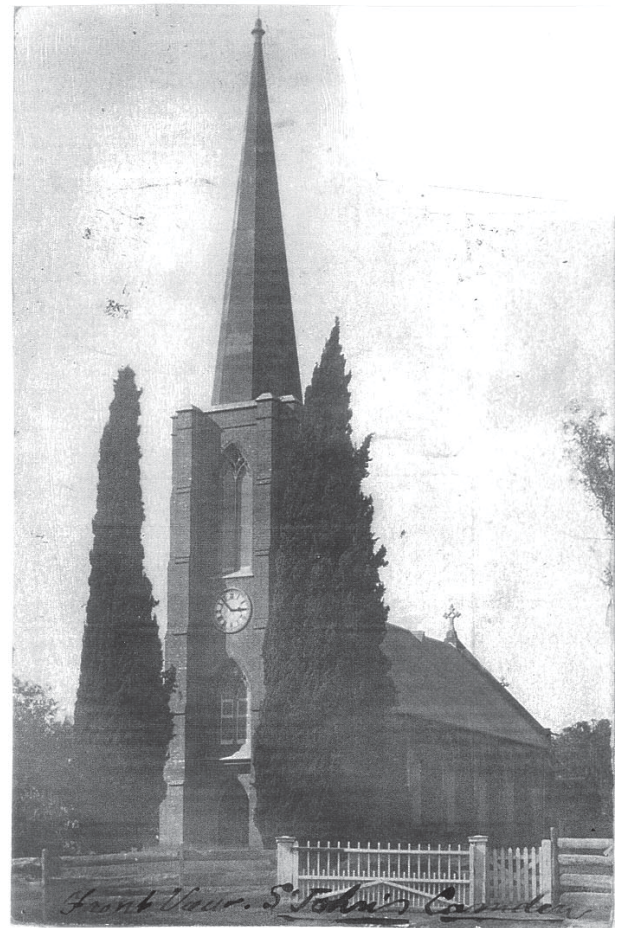
Figure A2.13a/b

Upper (a): The Menangle Road side entry to the church showing the lych gate installed in 1912 to Mrs Macarthur Onslow's memory

Lower (b): Photograph of same, but showing an earlier gate entry. Not dated, c1880s?

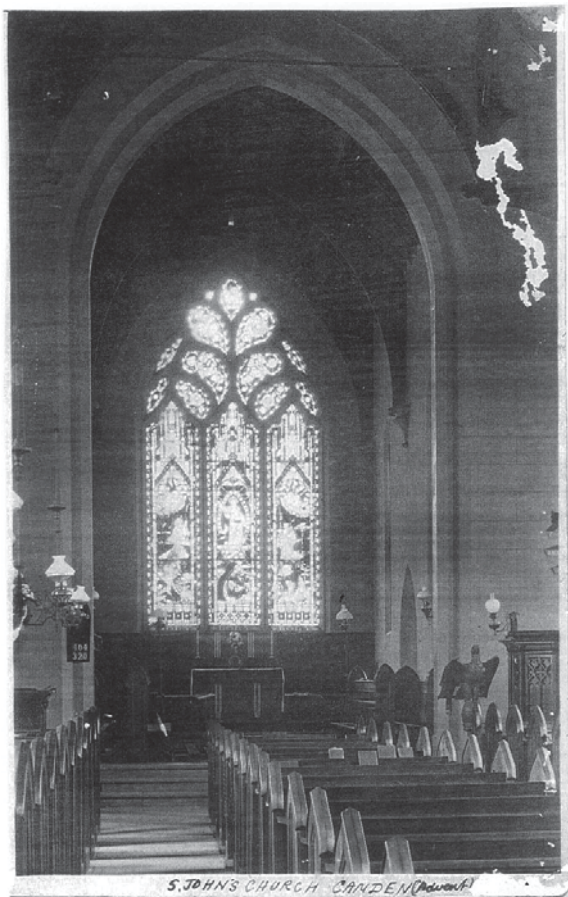
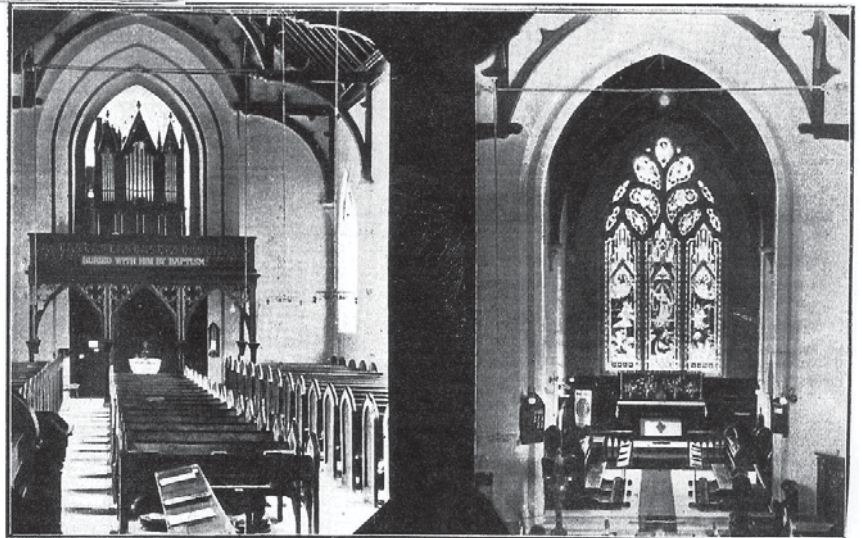
**Figure A2.14 a/b**

Upper (a): Photograph of church interior showing kerosene lighting fittings c1900s.

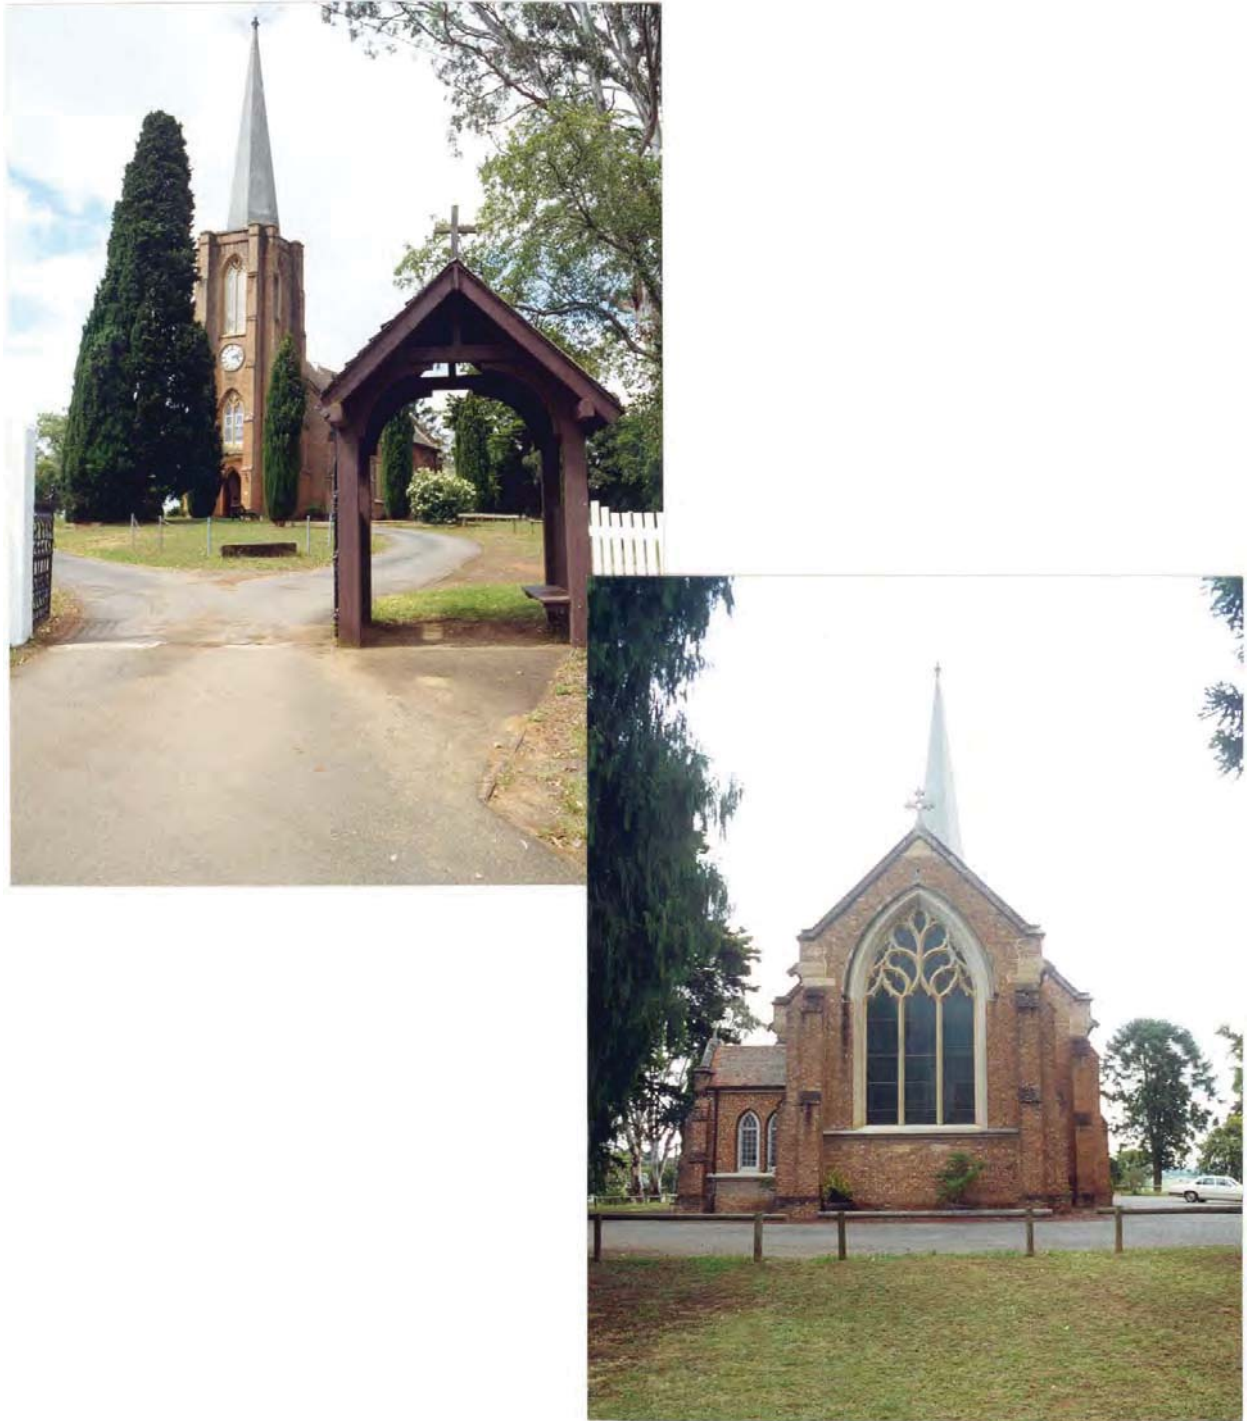
Figure A5.1a/b

Upper (a): St John's Church (from west): tower, spire, clock and drive from Menangle Road with lych gate (2000)
Lower (b): Chancel and vestry addition from east (2000)

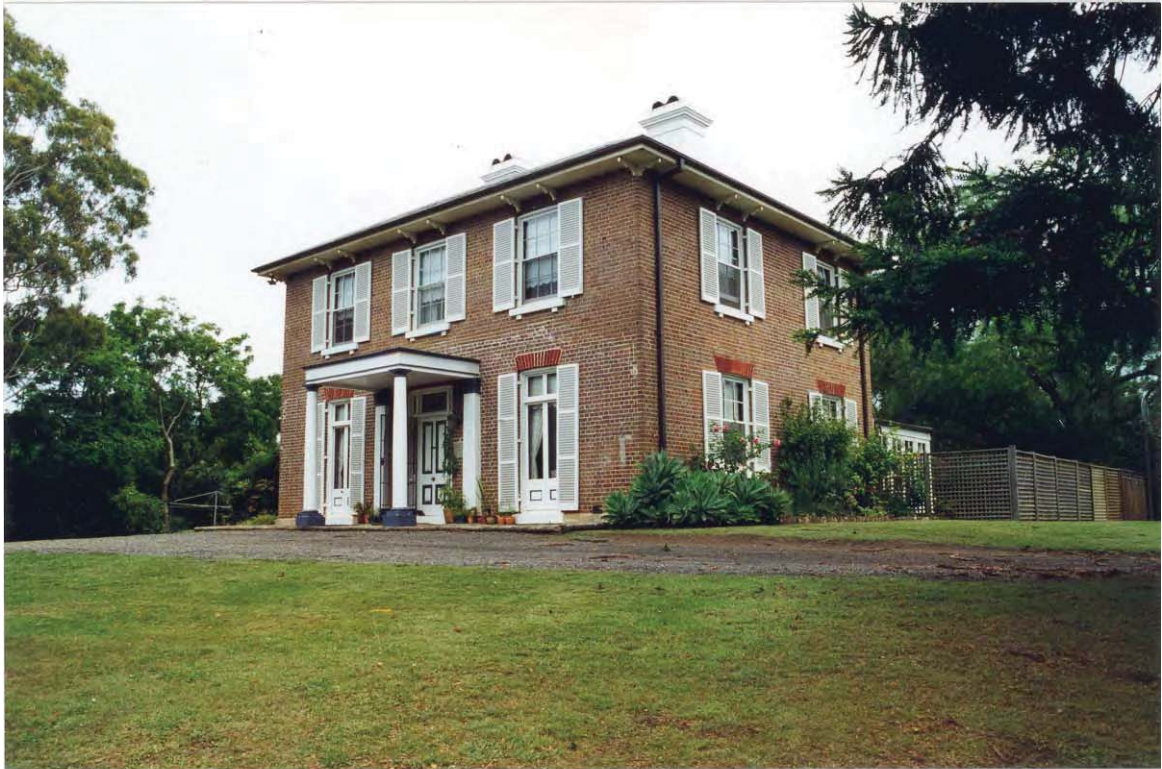
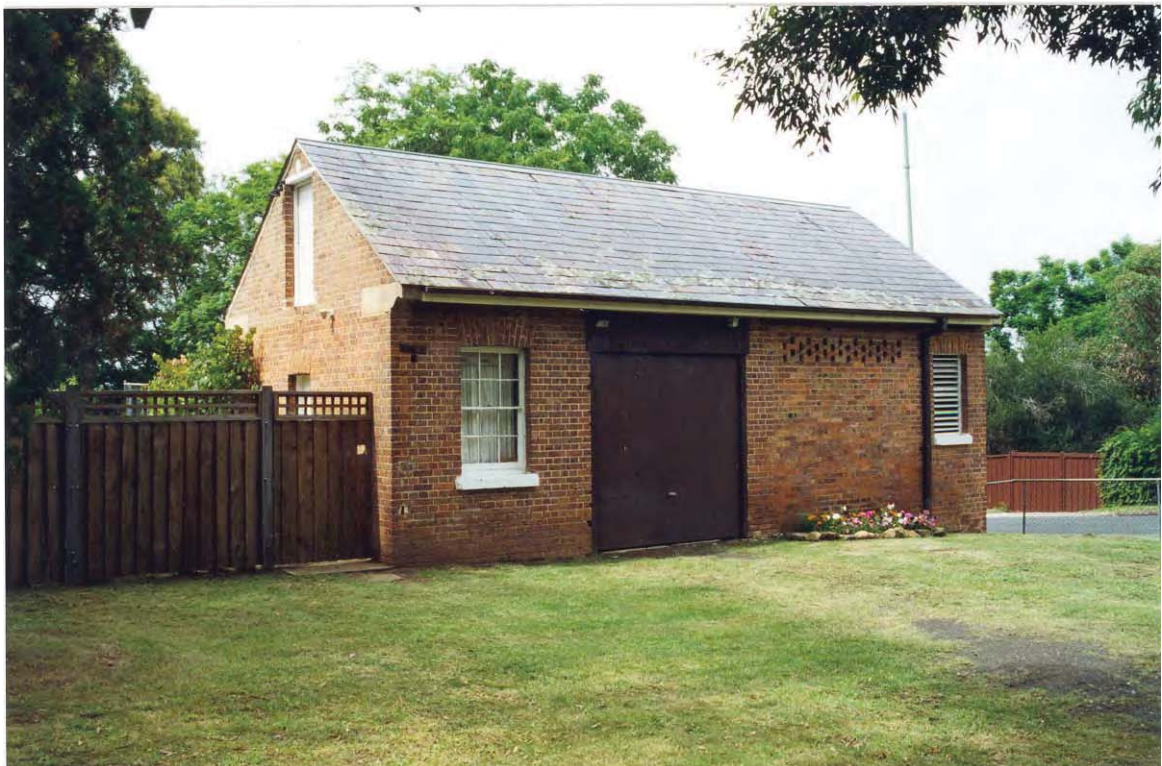
**Figure A5.3 a/b**

Upper (a): The rectory front (east) elevation (2000, prior to reconstruction of original verandah in 2003)
Lower (b): Former stables and coach house, shortened for the making of Forrest Crescent in 1968 (2000)

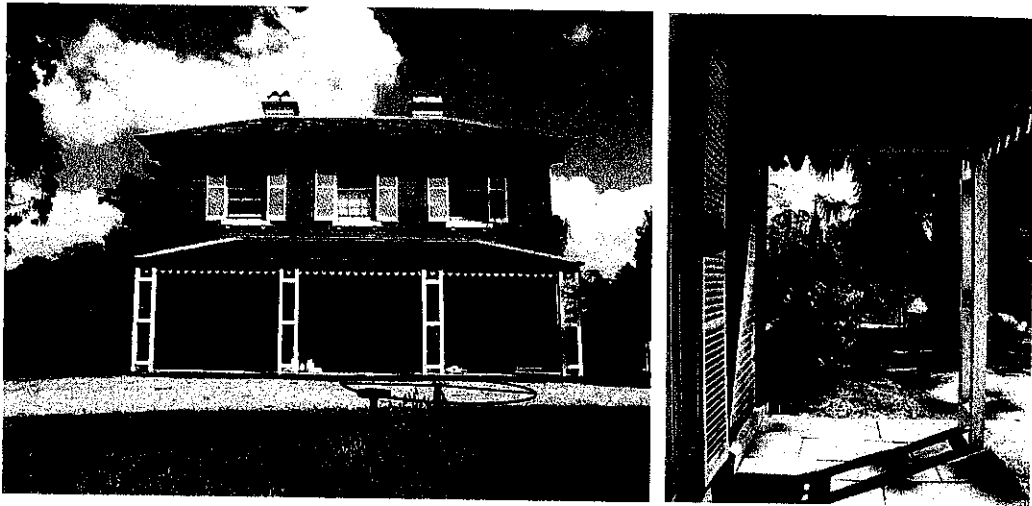
Figure 4 – East Elevation of the Rectory (left) and reinstated verandah (Source: NBRSPARTNERS, October 2010)

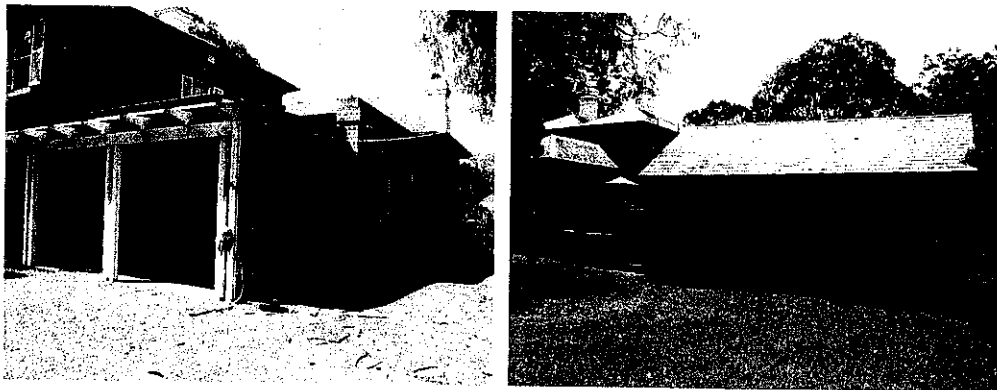
Figure 6 – Single-storey extension to West Elevation of Rectory (left) and Stables, West Elevation (right) (Source: NBRSPARTNERS, October 2010)

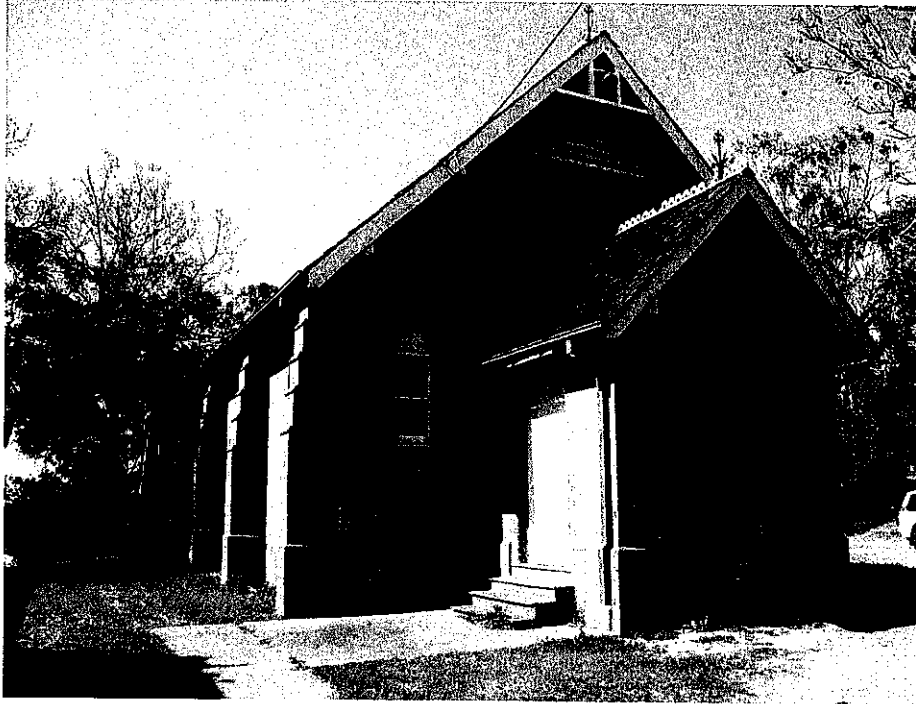
Figure 7 – Church Hall, North Elevation, facing onto Broughton Street (Source: NBRS+PARTNERS, October 2010)

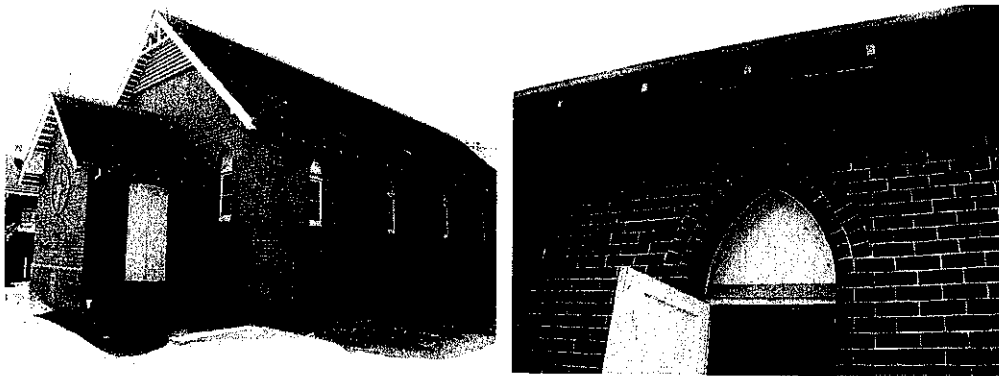
Figure 8 – Church Hall, West Elevation (left) and view of the western wall showing the cracking in the brickwork above the arched door entry (right). The structural cracking has been alleviated by connecting downpipe to water mains to reduce moisture affecting soil conditions under the building (Source: NBRS+PARTNERS, October 2010)

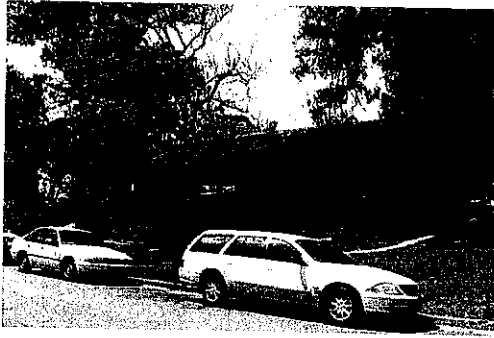
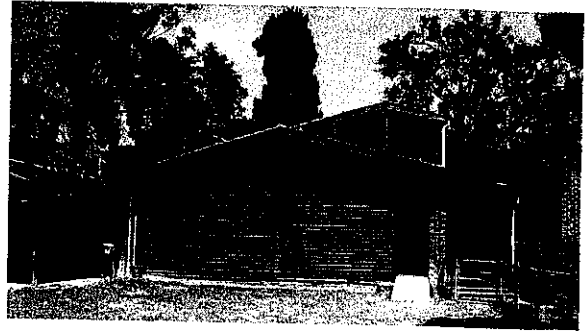
Figure 9 – Community Hall, West Elevation (left) and North Elevation (right) (Source: NBRS+PARTNERS, Oct 2010)

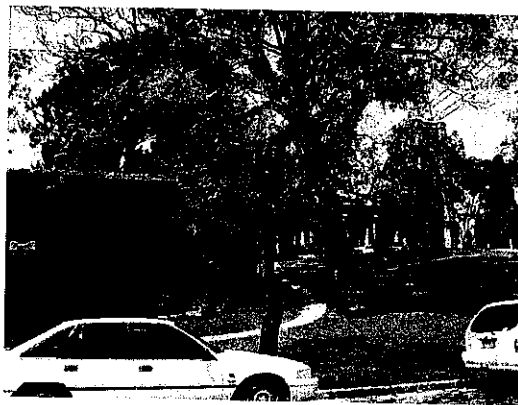
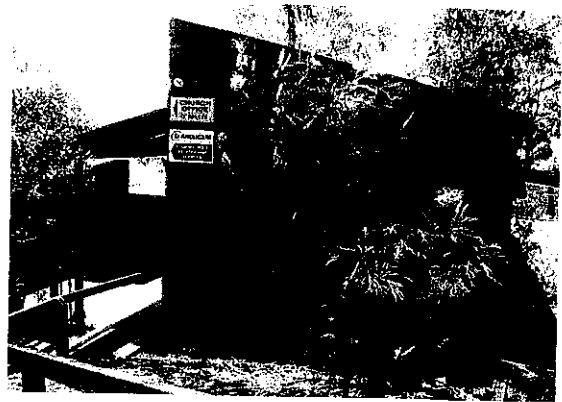
Figure 10 – View from Broughton Street showing the relationship between the Community Hall, and the Church (left). St John's Anglican Church Office (right) (Source: NBRS+PARTNERS, Oct 2010)

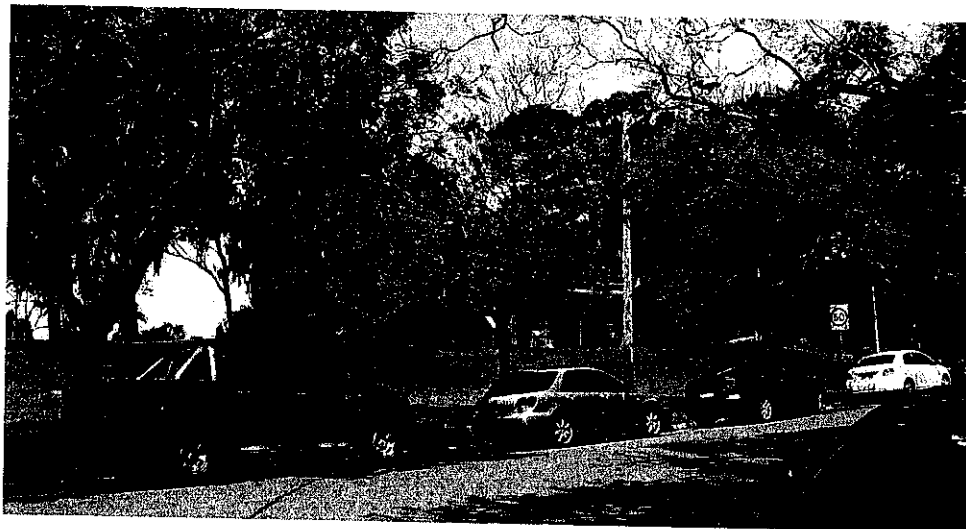
Figure 11 – View to church grounds from Broughton Street showing church obscured by Church hall (1973) and tree plantings (Source: NBRS+PARTNERS, Oct 2010)

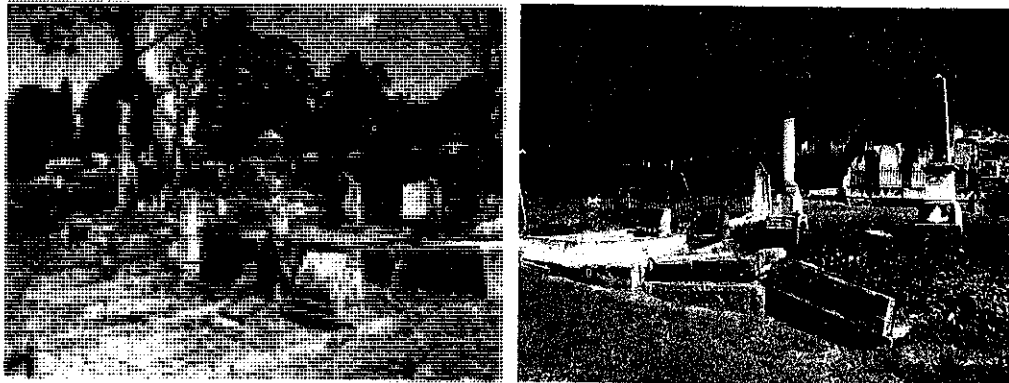
Figure 12 – Cemetery showing graves and gravestones, including some in ruinous condition and requiring conservation works (Source: NBRS+PARTNERS, October 2010)

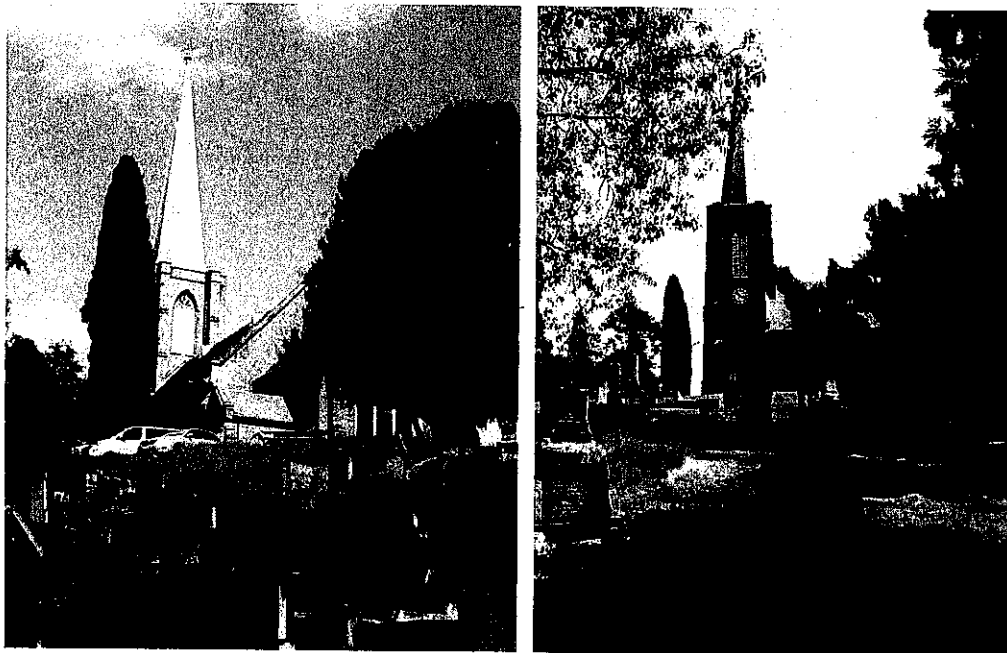
Figure 13 – Cemetery showing the condition of graves and gravestones. Specimen trees located within the cemetery are in good condition. There are significant views to the church and steeple from various areas within the graveyard (Source: NBRS+PARTNERS, October 2010)

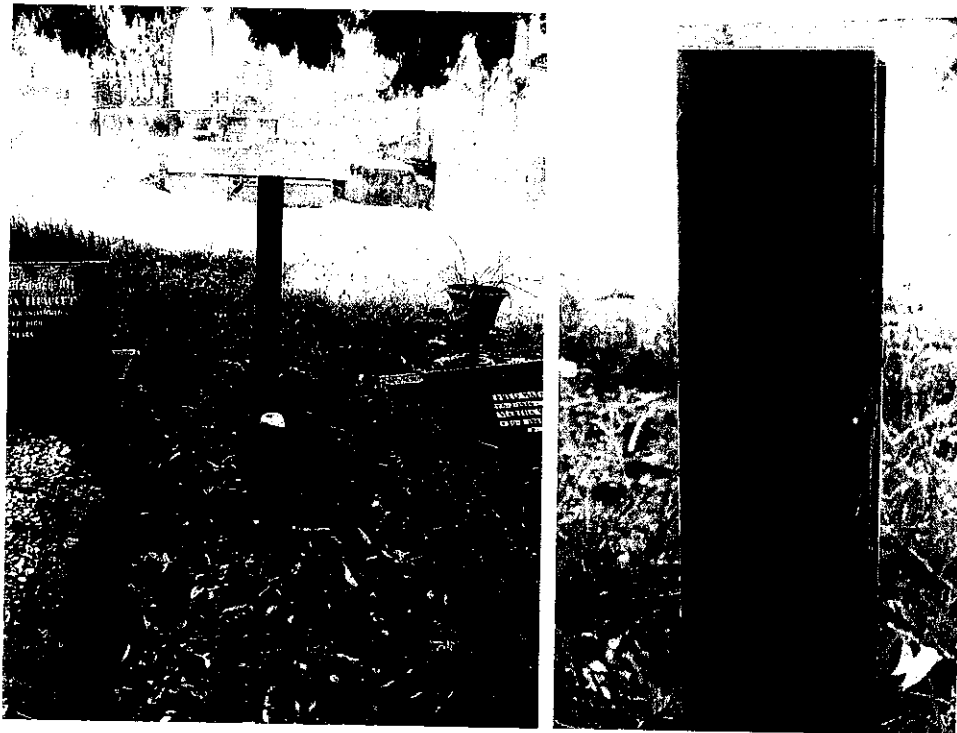
Figure 15 – Cemetery showing unmarked plot recently identified by relative who proposes a headstone be made for the grave site. This has raised issues as to the style of headstone to be used for a 19th century burial (Source: NBRS+PARTNERS, October 2010)

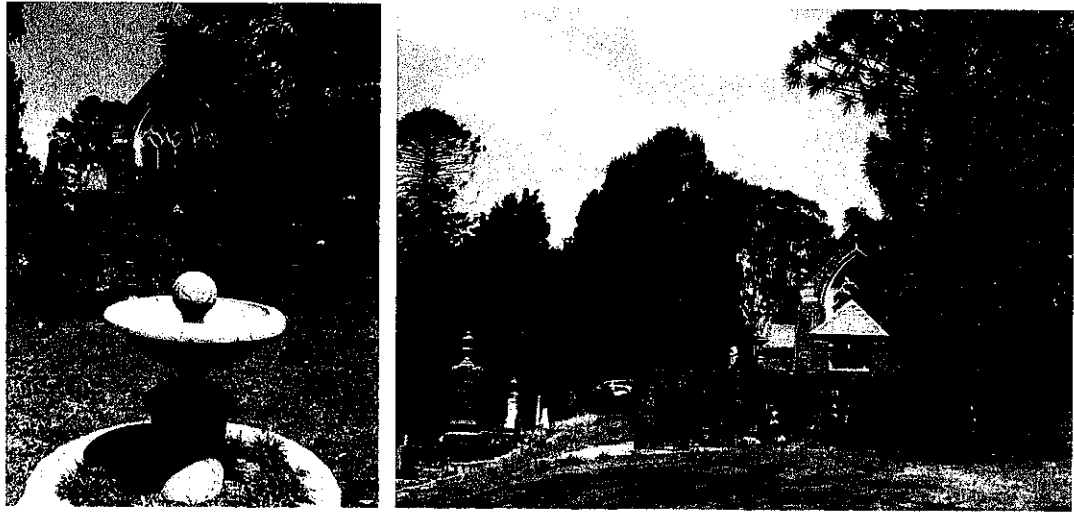
Figure 16 – Columbarium is located to the east of the Church, and north of the cemetery. It is necessary to extend the columbarium (Source: NBRSPARTNERS, October 2010)

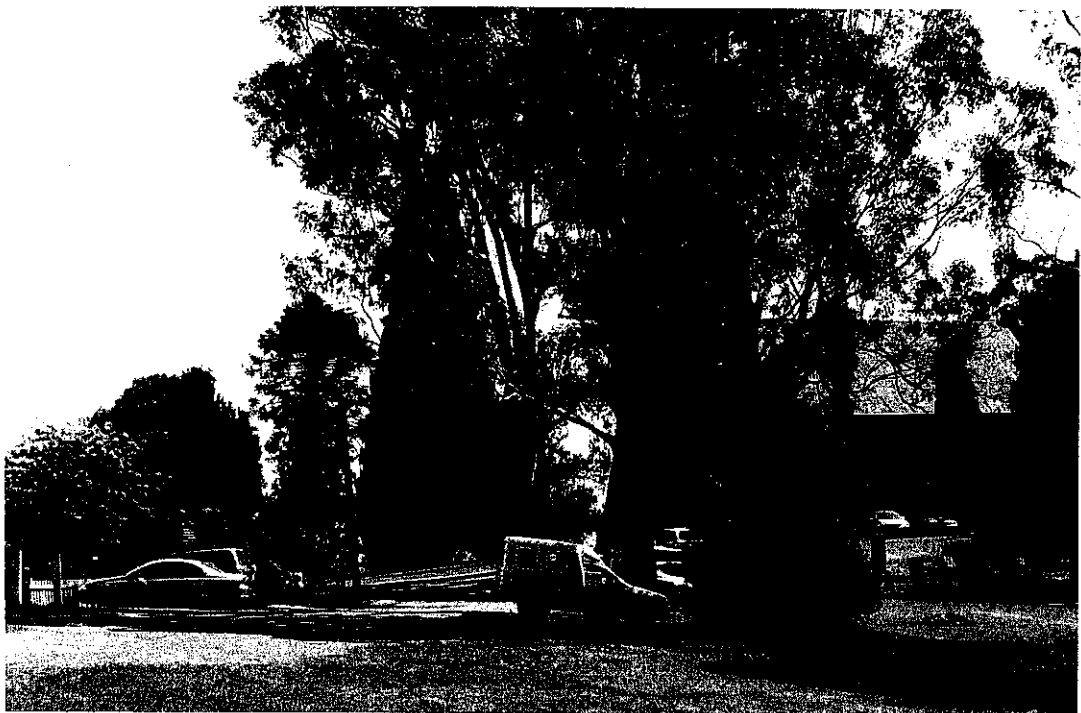
Figure 17 – Views from the Horse Paddock looking north to St John's Church. Carparking is located in the middle ground (Source: NBRSPARTNERS, October 2010)

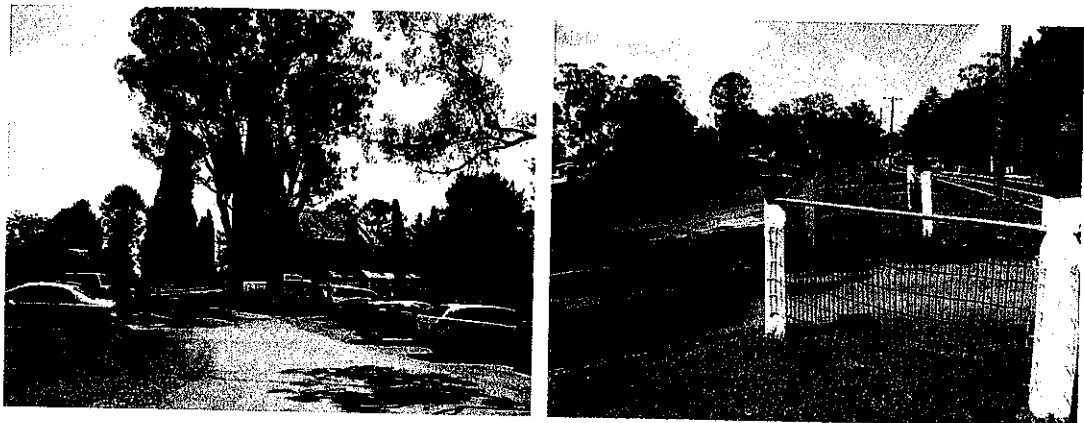
Figure 19 – View north through St John's Church Carpark to church (left) and timber entry gates from Menangle Road to Church (right) (Source: NBRS+PARTNERS, Oct 2010)

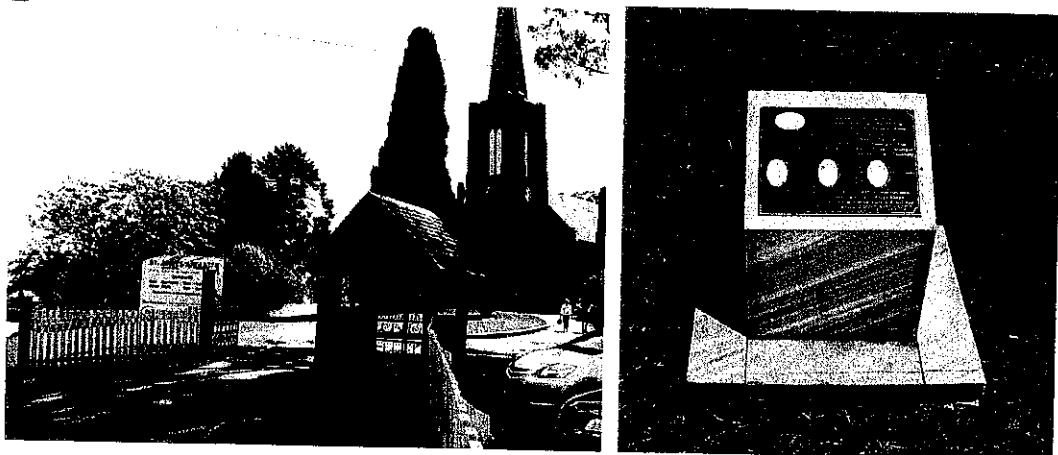
Figure 20 – View from Menangle Road to Church showing timber fence, vehicular entry and lych gate installed in 1912 (left). Memorial in church grounds to "the Crew and Passengers of RAAF De Havilland Dragon A34-47" (right). The memorial appears to have little association with the church (Source: NBRS+PARTNERS, Oct 2010)

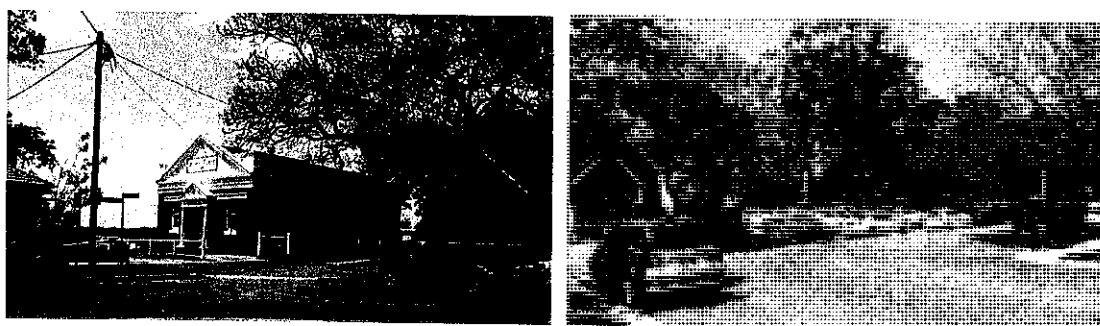
Figure 22 – View from the corner of Broughton and Hill Streets, looking east to Masonic Hall and the Church Hall (left), and southwest to the landscaped area between the two Community Halls (Source: NBRS+PARTNERS, Oct 2010)

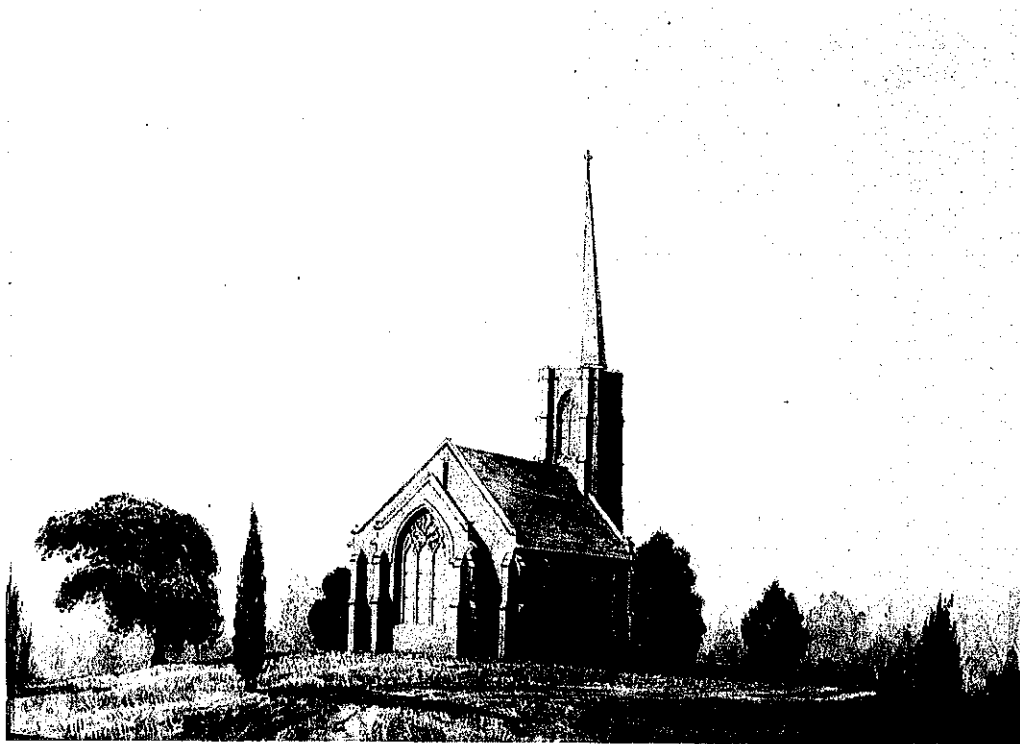
*Figure 25 – Unknown artist, St John the Evangelist, Camden, c1850 Watercolour and ink, showing the church before the chancel extension of 1873 (Source: Private collection –cited Joan Kerr and James Broadbent, *Gothick Taste in the Colony of NSW*, David Ell Press, Sydney, 1980, p113)*

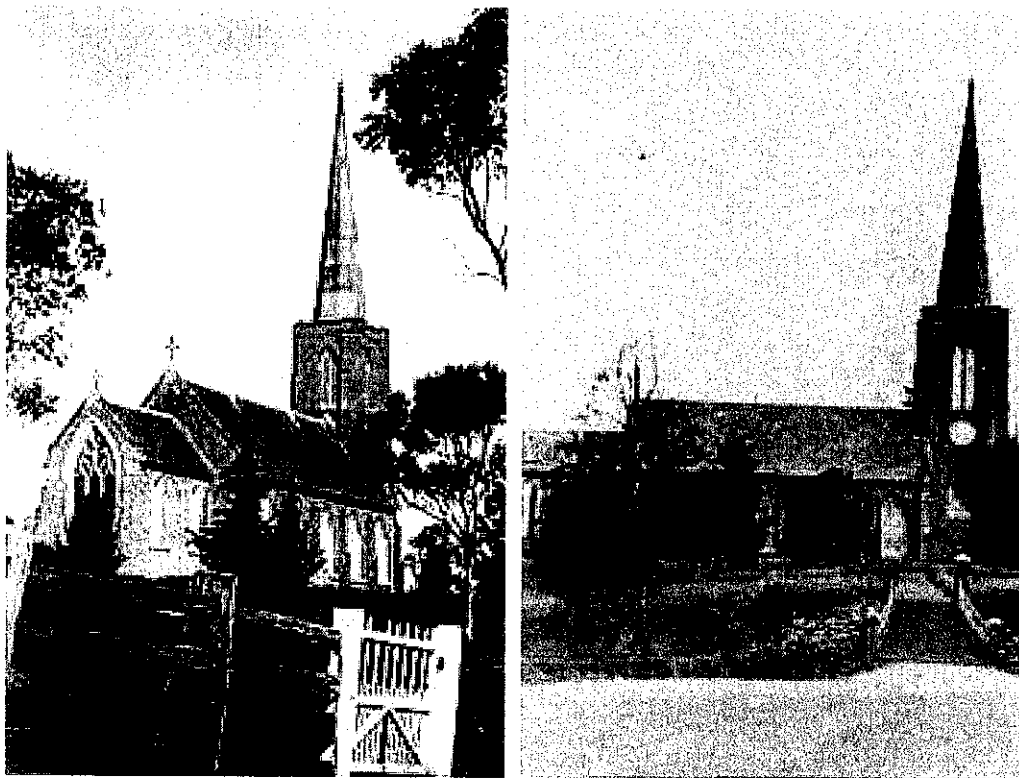
Figure 28 – From Broughton Street, c.1874 showing early gate (left) Looking from top of Johns Street at gateway and steps from Broughton Street erected 1935, date of photo c1935 (right) (Source: Camden Historic Society Library (left) Camden Council Library (right))

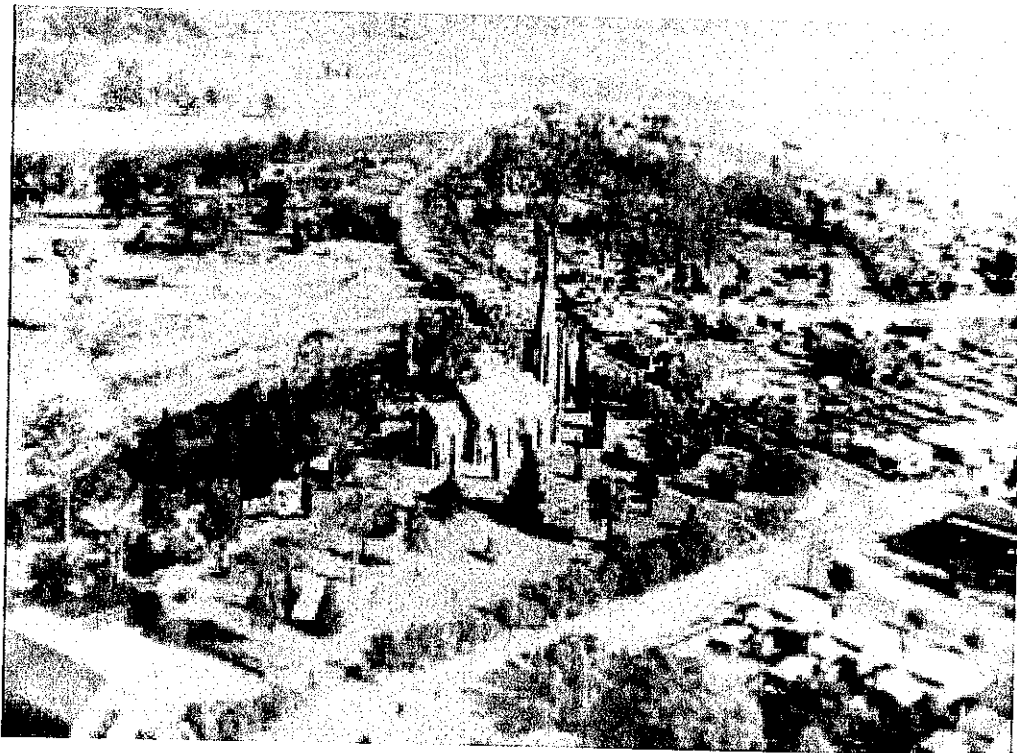
Figure 31 – Aerial view of St John's Church, Broughton Street, Menangle Road showing tree plantings along Broughton Road and the alignment of the path to the north of the cemetery connecting the Church Hall and church and a roadway from the Broughton Road to the church. West of the church hall is a tennis court with perimeter plantings. (Source: Camden Historical Society, photo taken prior to 1966)
