# *Camden Residents' Action Group*

Re:  
BP Service Station  
12 Argyle St Camden  
Development Approval (DAs: 257/2018; 411/2017)  
Consent Conditions

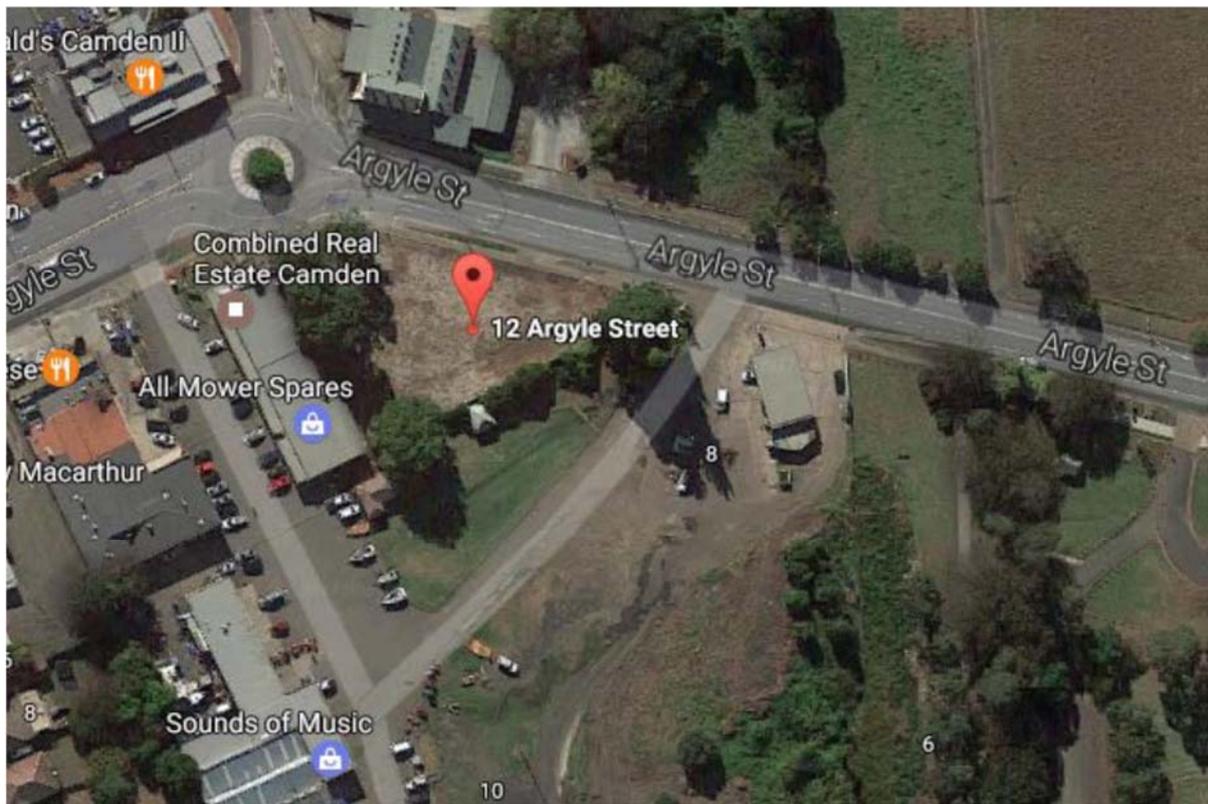
As can be seen in the aerial view below the area did contain significant stands of trees.

Source: Olga Blache (February 2018) *Arboricultural Impact Assessment*. Google Earth Imagery 24/1/17

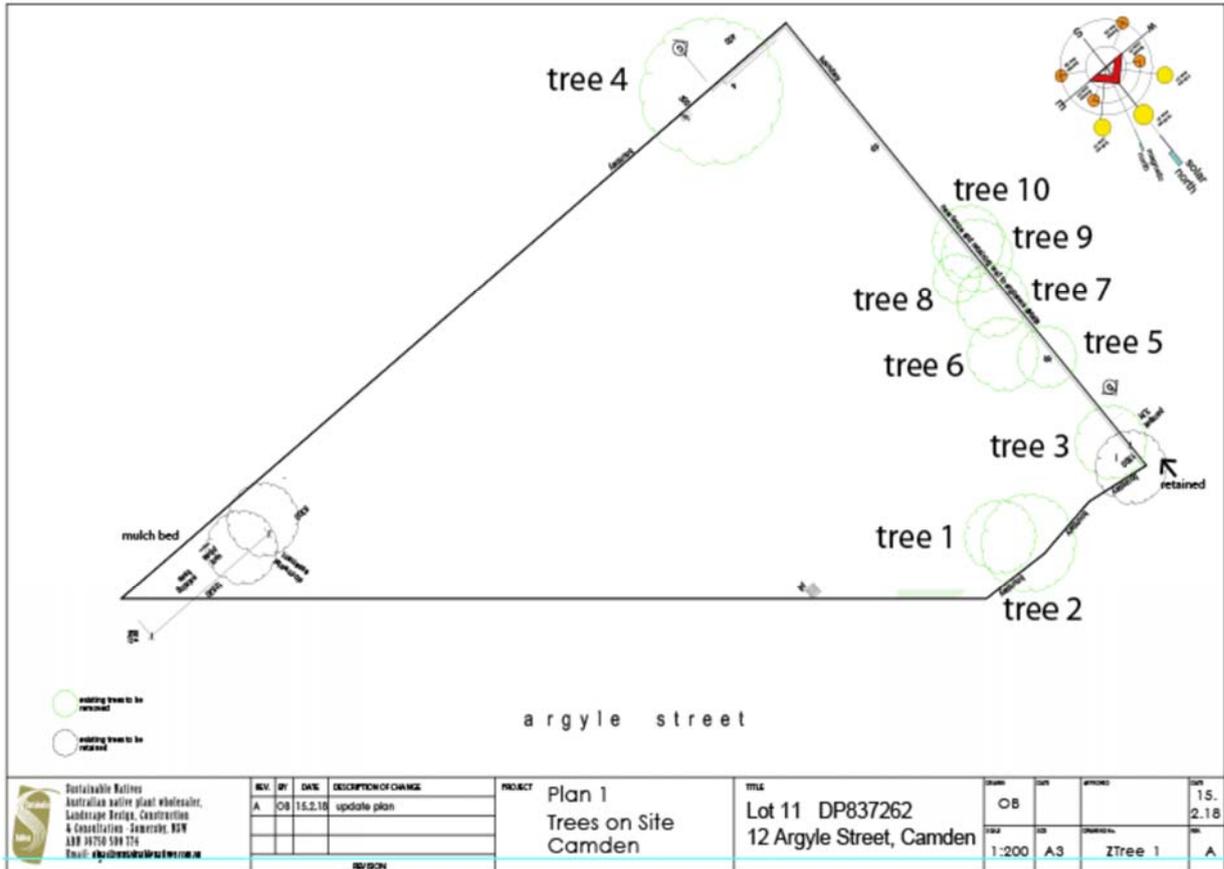
Ten trees were approved for removal.

They are numbered and depicted in green in the diagram below which also shows in black two trees in the eastern and one at the western corner of the site to be retained.

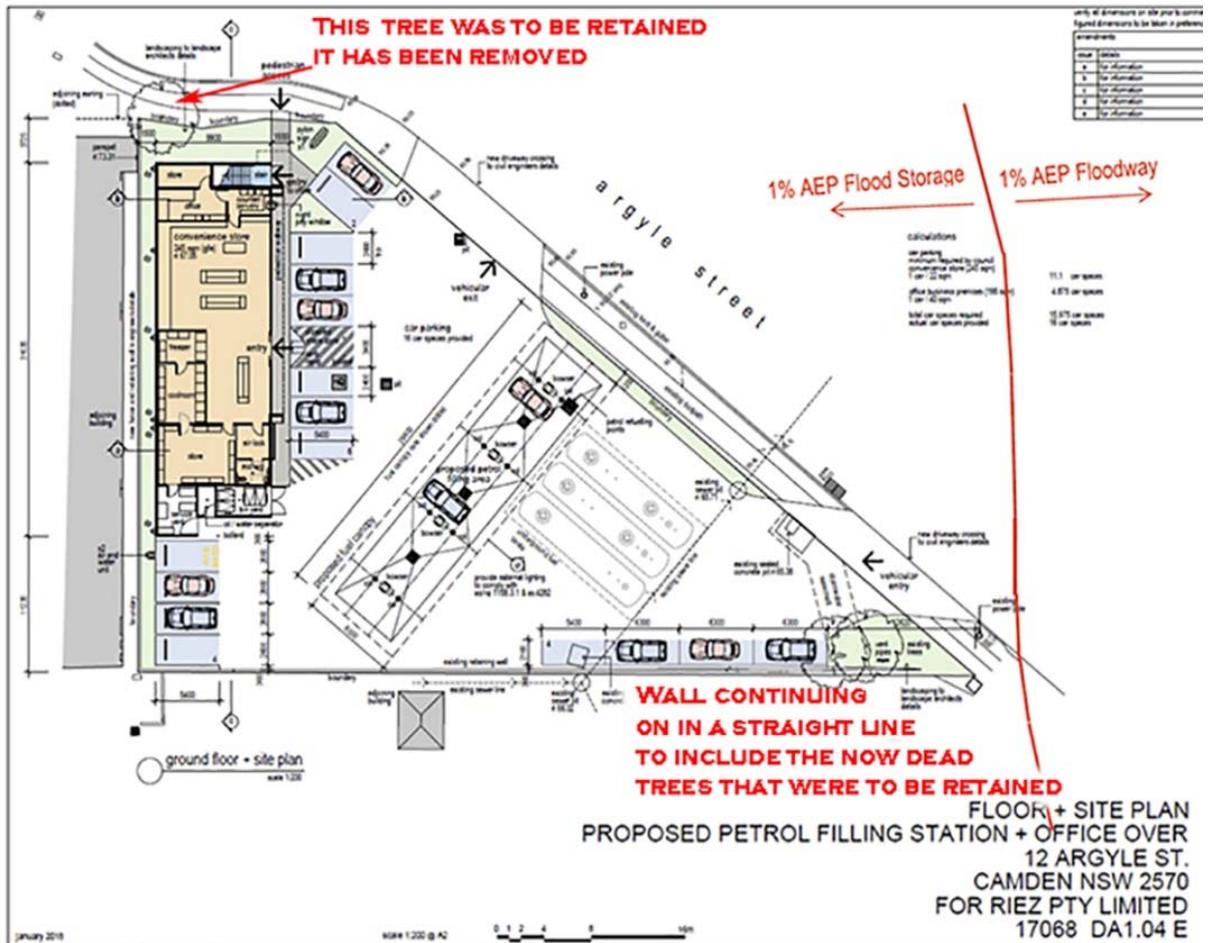
Likewise, the approved architectural drawing below shows the trees to be retained. Noted also are the trees that would seem to have not survived.

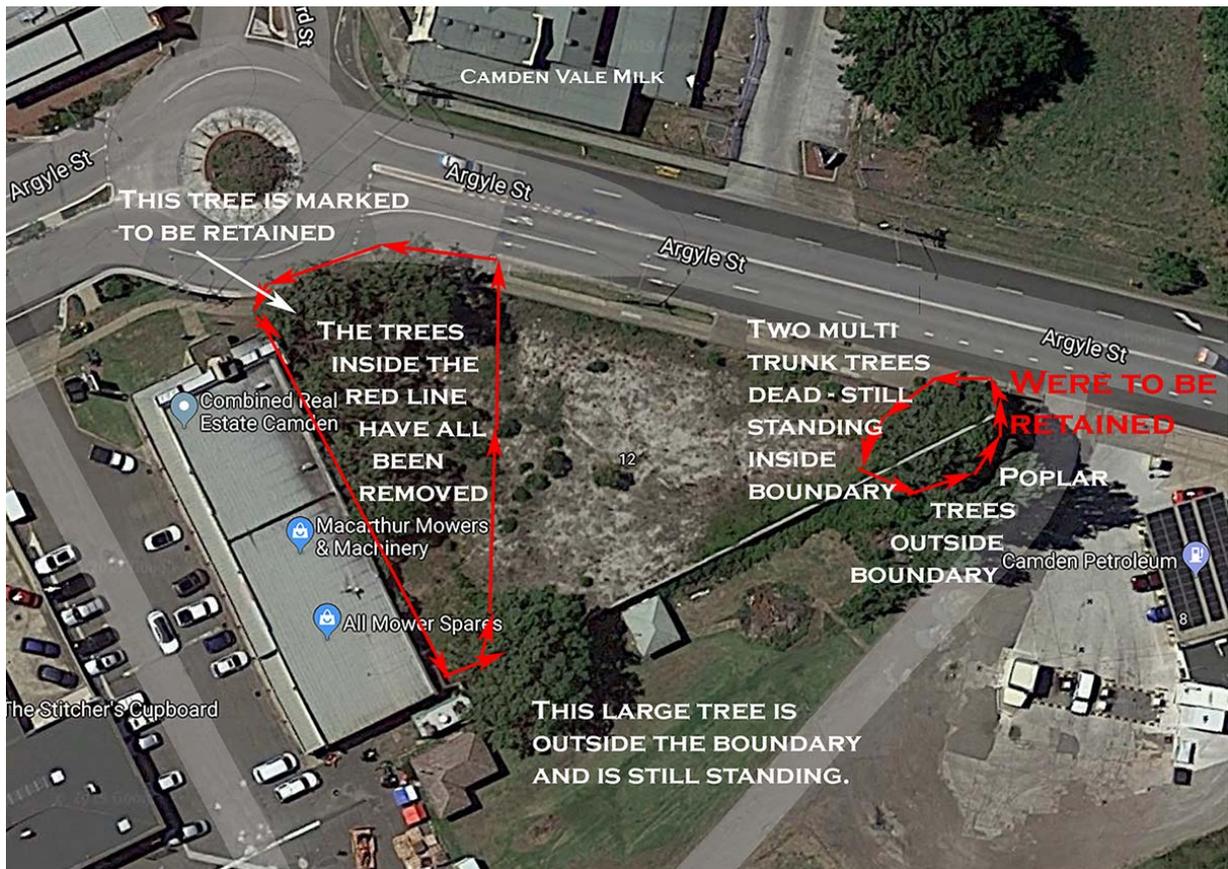
As depicted below it appears that the requirement and expectation that the development would retain trees within the site to soften its modern starkness at the main entrance to the historic town has not eventuated.

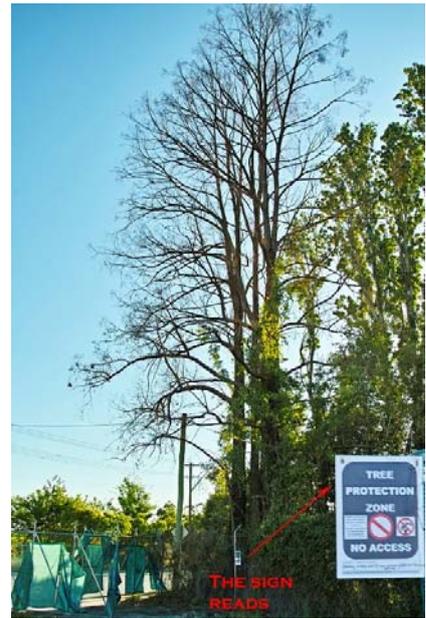
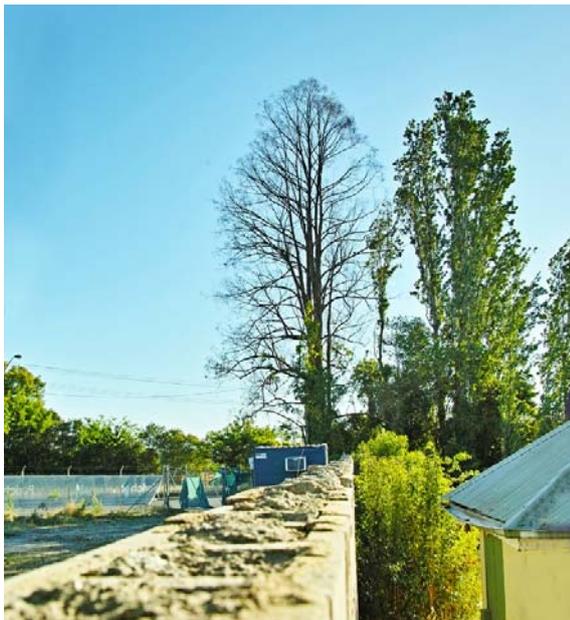
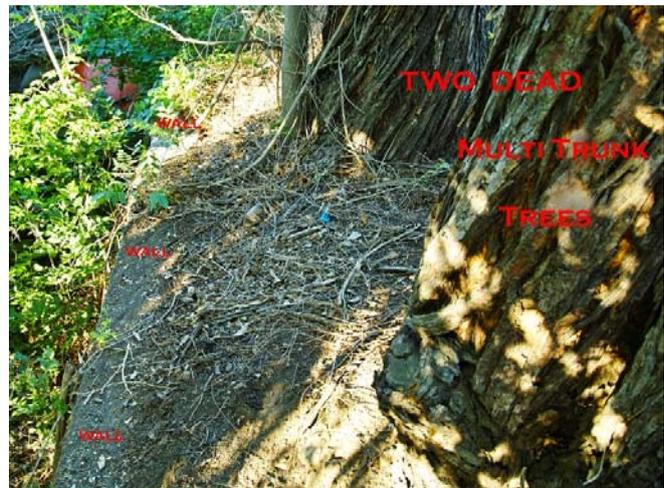
*Photos: 15 November 2019*

We also continue to be concerned, as raised in our letter of 14 August 2019, that trees at the eastern corner of the site (multi-trunked Tallowwood; *Eucalyptus microcorys*) as shown in these photos exhibit uneven defoliation but trees adjacent to the site appear to be healthy. As shown below these multi-trunk trees at the lower continuation of the block wall on the boundary line of the neighbouring small service station appear now to be dead or close to dying.

This is also potentially a matter of public safety as dying trees can collapse unexpectedly.

We note that a tree protection zone has been signposted in the eastern corner.

### Why are these trees defoliated?

If the trees need fertilisation and watering then this can be remedied. If the trees have been subject to inappropriate treatment then an arboreal expert may be able to recover their health.

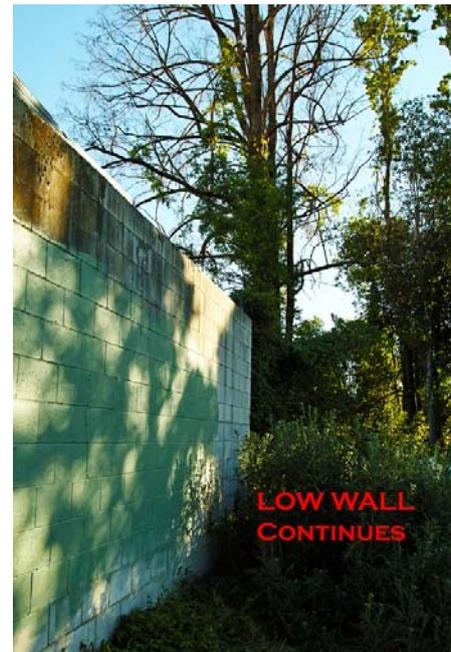
*Photo: 15 November 2019*

The other issue of public interest raised in our letter of 14 August 2019, was the safety of the unsupported block wall on the site which is located within a floodway according to the lived experience of the community.

We note that it is a condition of consent that the structural soundness of this wall be subject to certification.

Again, as with the defoliated trees, we note that this matter is potentially one of public safety.
