Camden Residents' Action Group

URGENT REQUEST FOR MEETING **Argyle St works and health of Jacaranda and other street trees**

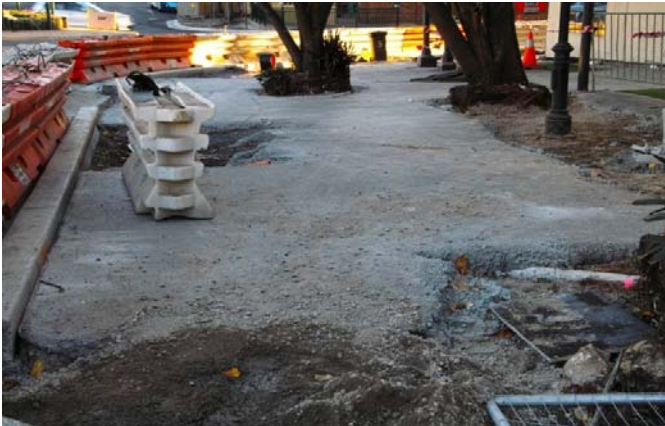
Further, the health of all Argyle Street trees is at risk because the works have damaged the water system. Until a water system was installed in 2008 - 2009 the trees struggled to survive and grow. Storm water pipes trenches have cut through the median strip in four places plus at the two sets of traffic lights. Instead of just two water controls there will need to be many. A considerable amount was invested in the water system, which now needs major repairs or to be replaced.
