Camden Residents' Action Group Incorporated Camden – Still a Country Town

4 March 2020

Re: BP Service Station 12 Argyle St Camden Development Approval (DAs: 257/2018; 411/2017) **Consent Conditions** 13 December 2018

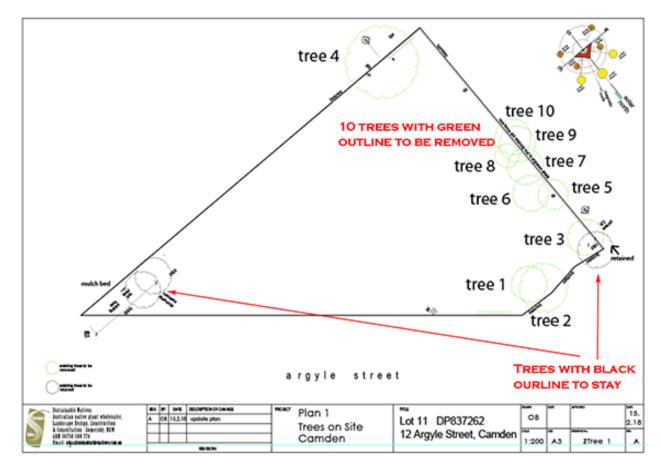
Figure 2. Location 12 Argyle Street, Camden (Existing Trees Camden Drawing dated 15/02/2018) Source: Olga Blacha Aboricultural Report (p. 3)

The consent conditions¹ of DA approval included tree and vegetation protection (condition 7), and compliance with the Landscape Plan² showing trees that were to be retained and with an Aboricultural Report³ with the stated aim (p.4) of the retained trees remaining in a safe and healthy condition, not less than at the time of initial inspection for the report, or in a reduced but sustainable condition due to the impact of the development but ameliorated through tree protection measures. The Landscape Plan and Aboricultural Report clearly indicate the trees to be retained. The diagram below has been annotated for clarity.

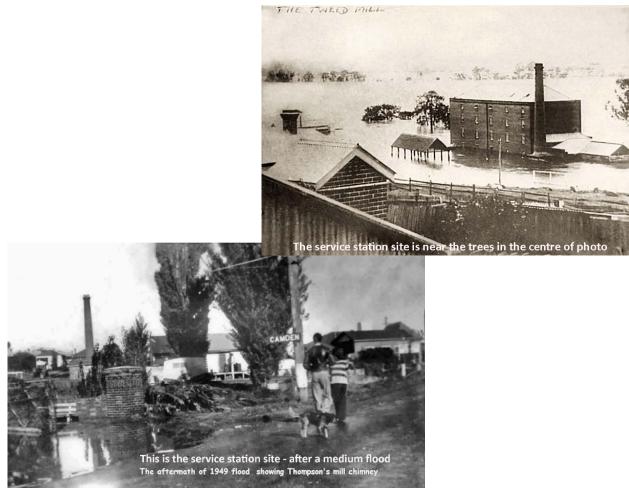
The site is within a high hazard flood zone, and lived experience is that it is in the path of fast flowing river water, which would suggest it is in a floodway rather than being a flood storage area as claimed.⁵

As well as these historic photos of flood events, we have provided recent photos in our previous two letters.

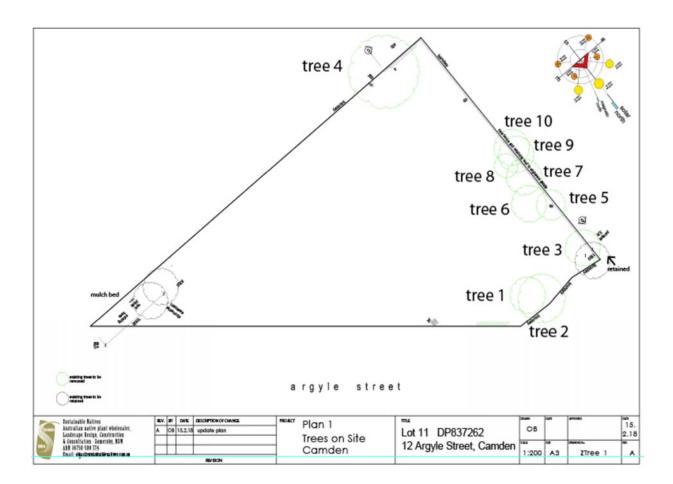
Ten trees were approved for removal.

They are numbered and depicted in green in the diagram below which also shows in black two trees in the eastern and one at the western corner of the site to be retained.

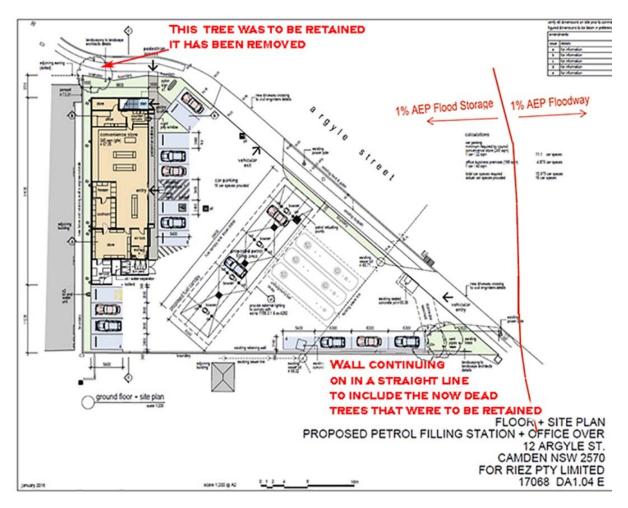
Likewise, the approved architectural drawing below shows the trees to be retained. Noted also are the trees that would seem to have not survived.

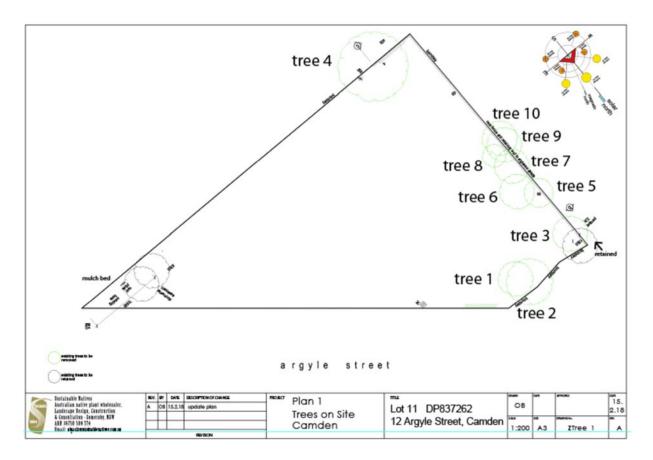
Removal of 10 mature trees as applied for in this DA, shown in the diagram below, was approved. We understand that the desirability of retention and enhancement of the leafiness and a tree-lined welcome to the acknowledged and renowned heritage town, is not disputed by developers, and is expected by residents and visitors.

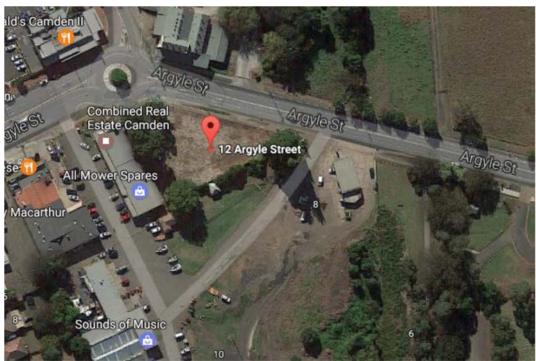
Source: Olga Blache (February 2018) Arboricultural Impact Assessment. Google Earth Imagery 24/1/17

We are concerned that trees either within or adjacent to the site (multi-trunked Tallowwood; Eucalyptus microcorys) exhibit uneven defoliation and appear to be dying.

We note in particular that the eastern stand of trees on Argyle Street is to remain. Trees near to neighbouring business, Combined Real Estate, appear to have been dying since the latter part of 2018 and more recently trees have been observed to be dying near to the neighbouring service station, the Hot Spot.
